U.S. Department
of Transportation
**Federal Aviation
Administration**

Western-Pacific Region
Airports District Office

August 27, 2019

On August 16, 2019, site visit was conducted at the Reid-Hillview of Santa Clara County Airport (RHV) with Mr. Abel Tapia. This visit was a follow-up to the June 2019 visit to determine what progress has been made. An airfield inspection was conducted and the following items were noted:

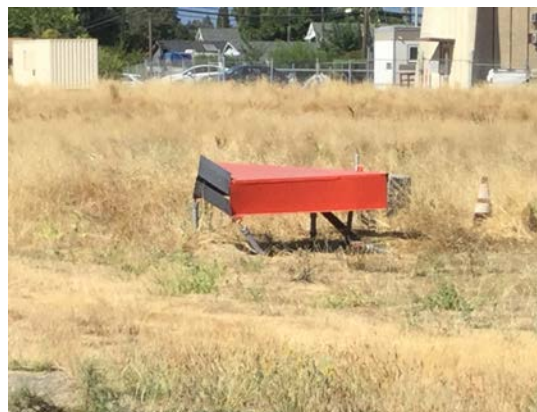
3. Decommissioned visual approach slope indicators (VASI) was observed in the safety areas of Runway 13R/31L and 13L/31R. Precision approach path indicators have been installed. Recommend the airport sponsor work with the San Francisco Airport District Office (SFO ADO) and Tech Ops to have the old VASIs removed.

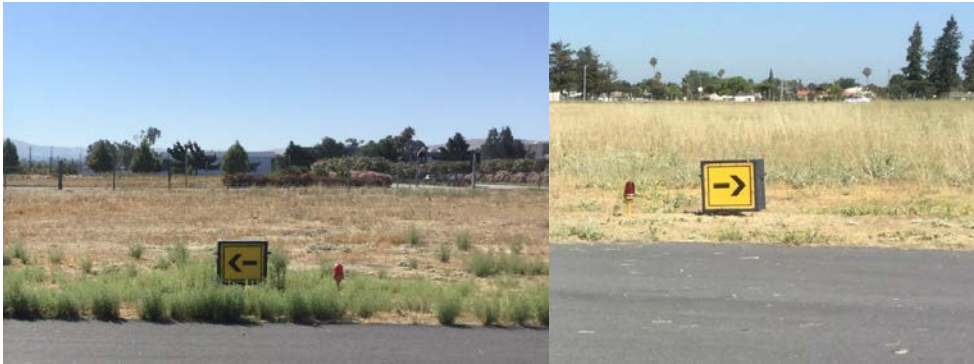
4. Non-standard signs with a single arrow were observed at the approach and departure end of Runway 13L. The sign does not include a destination and should be removed. All

signs should be in accordance with Advisory Circular (AC) 150/5340-18, *Standards for Airport Sign Systems*.

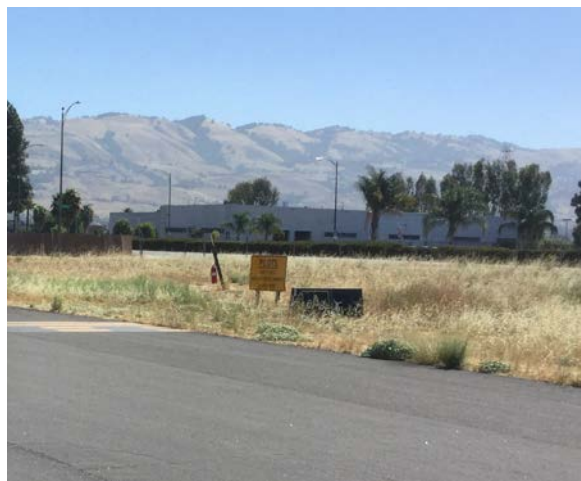
7. Grass was found obscuring Taxiways Bravo and Charlie exit signs on Runway 13L/31R and Taxiway Golf direction sign along Taxiway Zulu. Grass was also obscuring two no entry signs along Runway 13R/31L, indicating that entry into a particular area is prohibited to aircraft. Signs should be visible in such a way they provide the pilot or vehicle driver the ability to easily identify routes toward a desired destination. Recommend the airport sponsor mow the grass to ensure all signs are visible.

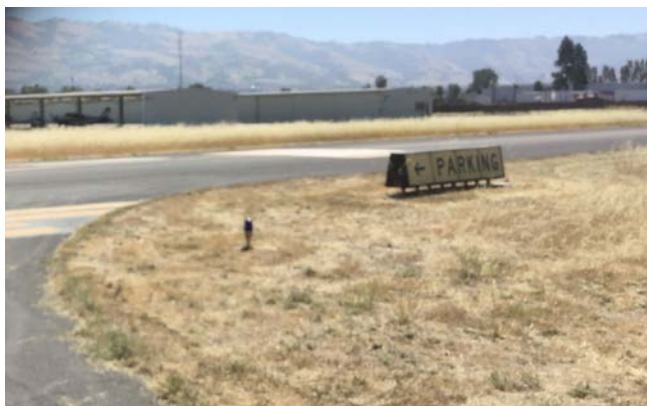
8. A non-standard inbound destination sign indicating PARKING was found on the back side of a mandatory holding position sign at Taxiway Bravo. A surface painted inbound destination sign indicating RAMP was found on Taxiway Yankee. In accordance with AC 150/5340-18, *Standards for Airport Sign Systems*, sign inscriptions should be consistent; do not use two different inscriptions for the same area (e.g. RAMP and APRON). Recommend the airport sponsor remove the inbound destination PARKING sign panel and replace it with a direction sign indicating Taxiway Charlie since there is no prior indication of the taxiway leading out of the intersection. The sign should have black inscriptions on a yellow background and contain arrows.
