7. Reid Hillview Airport

B. Administration/Terminal Building:

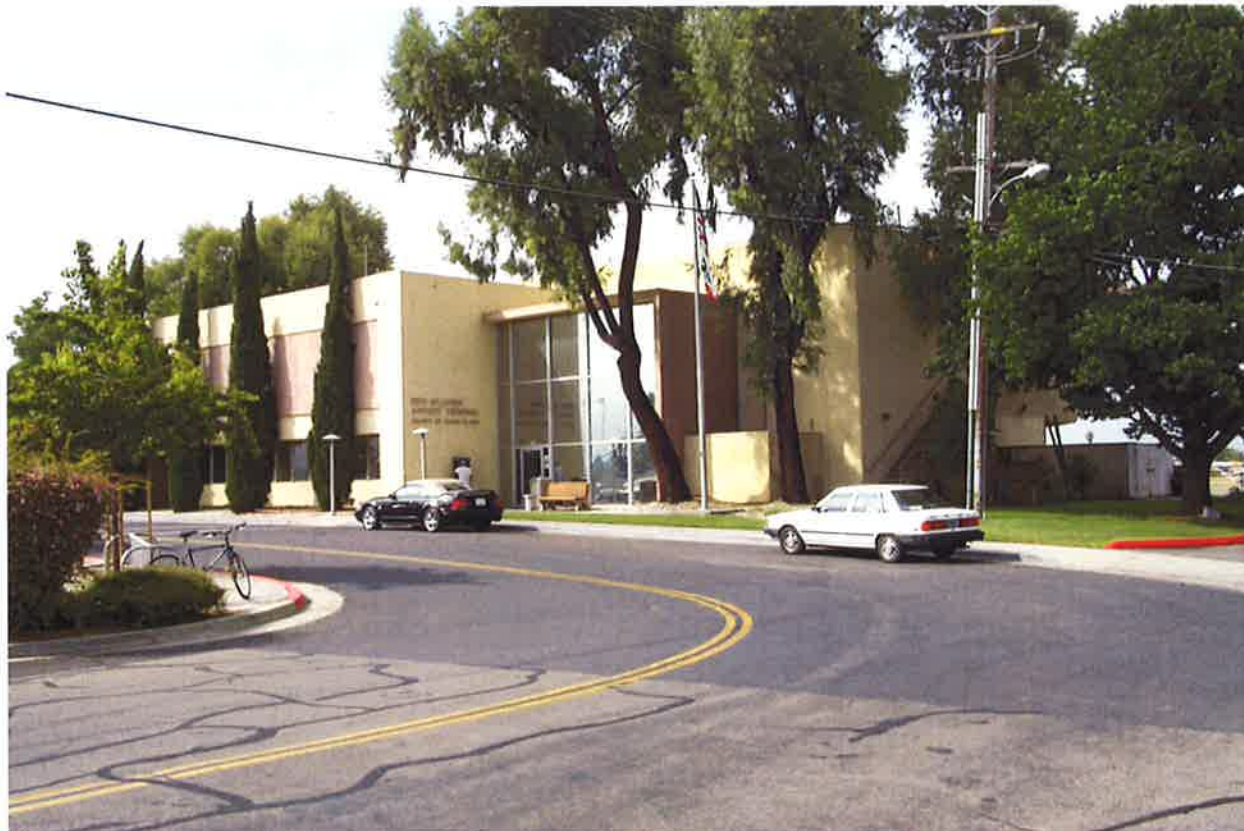
a. This structure is a two-story office building of 10,120 square feet reportedly built in 1970. The first floor of the building is currently being used as offices for the administration of the Reid Hillview Airport. The second floor is not occupied and was last used as a drinking and dining facility.
