Facility Condition Assessment Report Santa Clara County Airports

*Prepared by Kitchell
For*

County of Santa Clara, California

Reid Hillview Airport Terminal Building Facility Condition Assessment

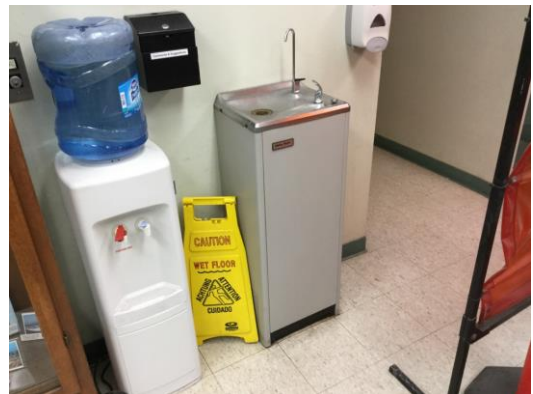
Building Name; Room or Area: Administration/Terminal Building
Equipment Tag: Drinking Fountain
Year Installed: NA
Expected Useful Life (Yrs):
Remaining Useful Life (Yrs)
Priority: 1: IMMEDIATE (Address in Year 0-2)

Description of Work: *Provide equipment replacement and installation.*

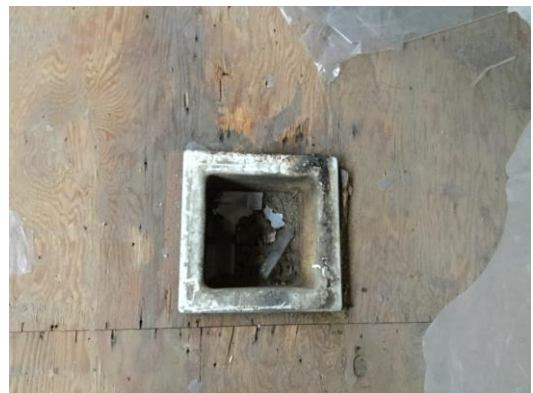
Building Name; Room or Area: Administration/Terminal Building
Equipment Tag: Floor sinks 2nd Floor
Year Installed: 1970
Expected Useful Life (Yrs):
Remaining Useful Life (Yrs)
Priority: 3: RECOMMENDED (Address in Years 5 to 10)

Description of Work: *Provide equipment replacement and installation.*

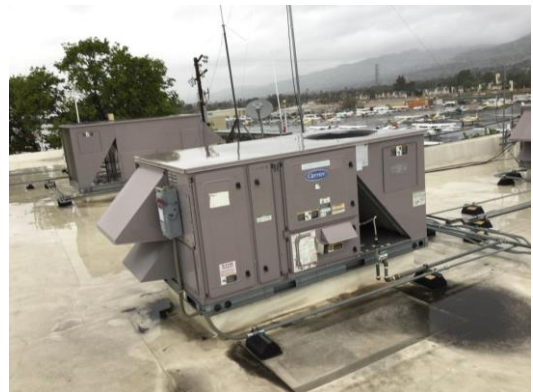
Building Name; Room or Area: Administration/Terminal Building
Equipment Tag: Package AC AC-4
Year Installed: 2007
Expected Useful Life (Yrs): 18
Remaining Useful Life (Yrs) 7
Priority: 3: RECOMMENDED (Address in Years 5 to 10)

Description of Work: Provide equipment replacement and installation.

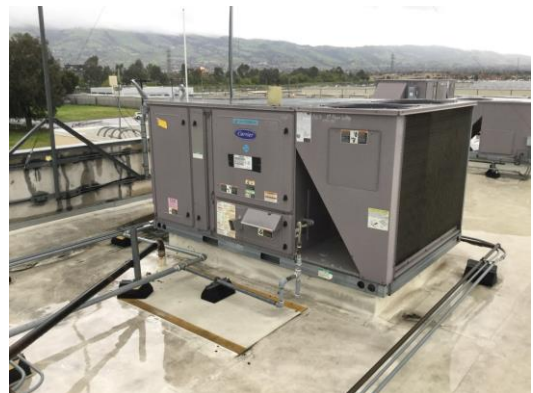
Building Name; Room or Area: Administration/Terminal Building
Equipment Tag: Package AC AC-3
Year Installed: 2007
Expected Useful Life (Yrs): 18
Remaining Useful Life (Yrs) 7
Priority: 3: RECOMMENDED (Address in Years 5 to 10)

Description of Work: Provide equipment replacement and installation.

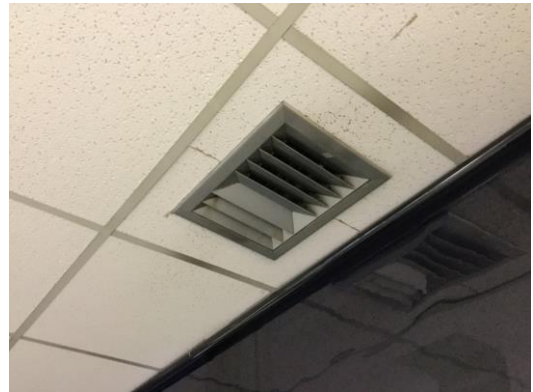
Building Name; Room or Area: Administration/Terminal Building
Equipment Tag: Diffusers
Year Installed: 1970
Expected Useful Life (Yrs): 30
Remaining Useful Life (Yrs) 6
Priority: 3: RECOMMENDED (Address in Years 5 to 10)

Description of Work: Provide equipment replacement and installation.

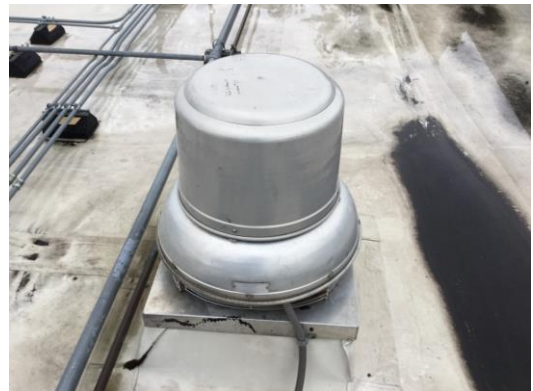
Building Name; Room or Area: Administration/Terminal Building
Equipment Tag: Exhaust Fan
Year Installed: 1969
Expected Useful Life (Yrs): 20
Remaining Useful Life (Yrs) 1
Priority: 1: IMMEDIATE (Address in Year 0-2)

Description of Work: Provide equipment replacement and installation.

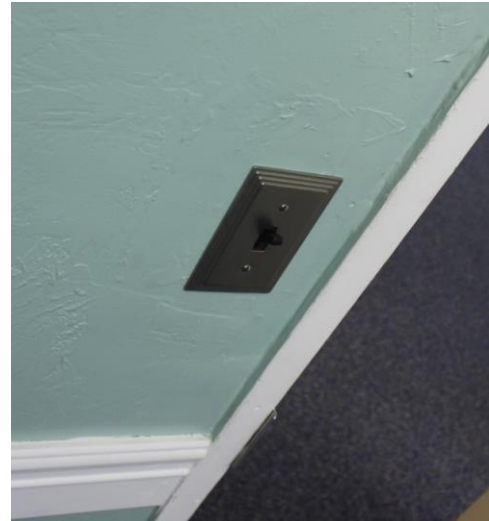
Building Name; Room or Area: Administration/Terminal Building
Equipment Tag: Ltg Controls
Year Installed: 1970
Expected Useful Life (Yrs): 20
Remaining Useful Life (Yrs)
Priority: 1: IMMEDIATE (Address in Year 0-2)
Quantity/Unit of Measure: 5,000/SF
Estimate: \$185,200
Deficiency Description: Interior lighting systems are at or are approaching the end of their expected useful lives.
Description of Work: Replace the existing interior lighting associated wiring devices, switches and controls to meet current energy codes.

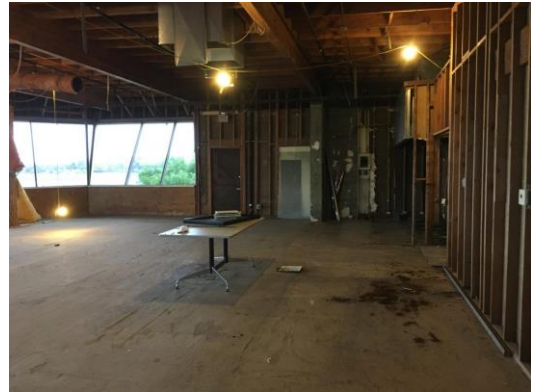
Building Name; Room or Area: Administration/Terminal Building; 2nd floor dining/kitchen build out
Equipment Tag: NA
Year Installed: 1970
Expected Useful Life (Yrs):
Remaining Useful Life (Yrs)
Priority: 3: RECOMMENDED (Address in Years 5 to 10)
Quantity/Unit of Measure: 1,900/SF
Estimate: \$3,094,700
Deficiency Description: Open area is demolished and not suited for occupancy.
Description of Work: Provide a new dining/kitchen area build-out for occupancy with general FF&E.

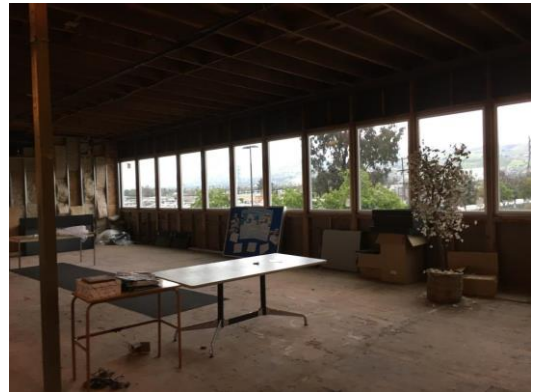
Building Name; Room or Area: Administration/Terminal Building; 2nd floor office build- out
Equipment Tag: NA
Year Installed: 1970
Expected Useful Life (Yrs):
Remaining Useful Life (Yrs)
Priority: 3: RECOMMENDED (Address in Years 5 to 10)
Quantity/Unit of Measure: 2,900/SF
Estimate: \$3,576,400
Deficiency Description: Open area is demolished and not suited for occupancy.
Description of Work: Provide a new open office area build-out for occupancy with general FF&E.

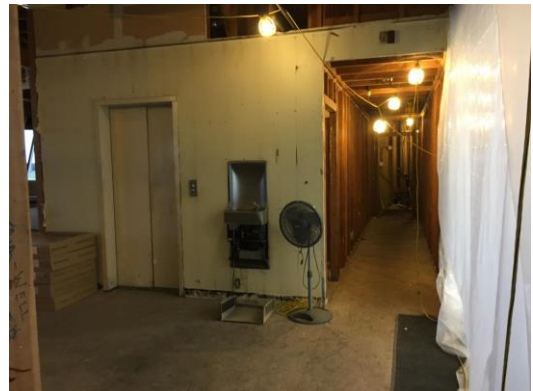
Building Name; Room or Area: Administration/Terminal Building; 2nd floor lobby build out
Equipment Tag: NA
Year Installed: 1970
Expected Useful Life (Yrs):
Remaining Useful Life (Yrs)
Priority: 3: RECOMMENDED (Address in Years 5 to 10)
Quantity/Unit of Measure: 250/SF
Estimate: \$291,100
Deficiency Description: Open area is demolished and not suited for occupancy.
Description of Work: Provide a new lobby area build-out for occupancy to accommodate for restaurant/office build-out with general FF&E.

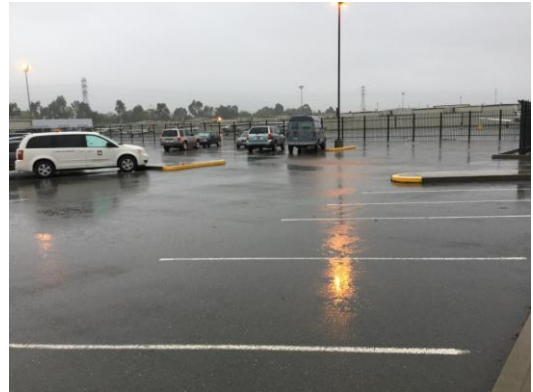
Building Name; Room or Area: Administration/Terminal Building
Equipment Tag: Parking lot concrete
Year Installed: NA
Expected Useful Life (Yrs):
Remaining Useful Life (Yrs)
Priority: 3: RECOMMENDED (Address in Years 5 to 10)
Quantity/Unit of Measure: 3,100/SF
Estimate: \$35,900
Deficiency Description: AC paving has faded or has minor weathering.
Description of Work: Provide chip seal.

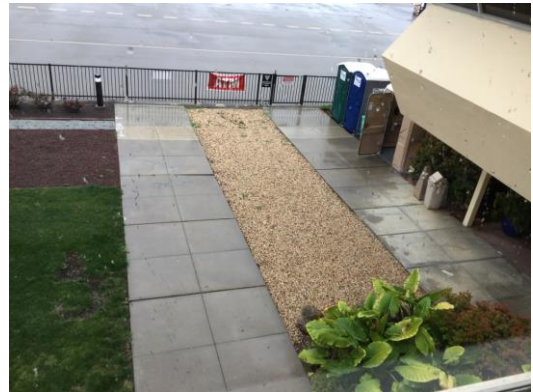
Building Name; Room or Area: Administration/Terminal Building
Equipment Tag: Sidewalk
Year Installed: NA
Expected Useful Life (Yrs):
Remaining Useful Life (Yrs)
Priority: 3: RECOMMENDED (Address in Years 5 to 10)
Quantity/Unit of Measure: 600/SF
Estimate: \$600
Deficiency Description: Concrete: Evidence of minor cracking (larger than 1/16").
Description of Work: Fill cracks above 1/16" width

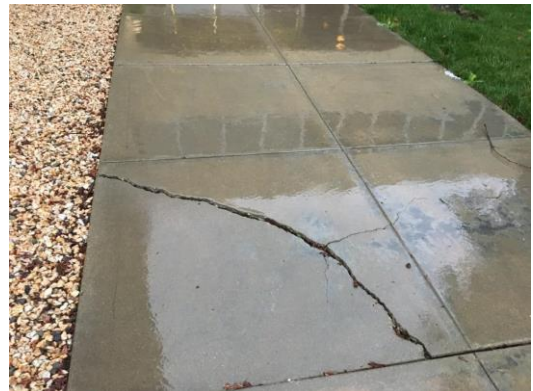
Building Name; Room or Area: Administration/Terminal Building; Exterior Paving
Equipment Tag: NA
Year Installed: 1970
Expected Useful Life (Yrs): 30
Remaining Useful Life (Yrs) 0
Priority: 1: IMMEDIATE (Address in Year 0-2)
Quantity/Unit of Measure: 75/SF
Estimate: \$2,000
Deficiency Description: Trip hazards are present (> 1 inch).
Description of Work: Repair and replace walkway to remove hazard.

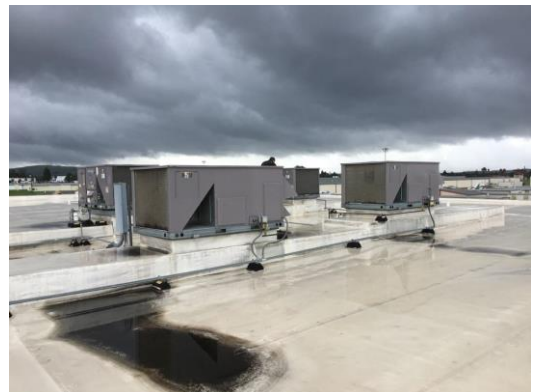
Building Name; Room or Area: Administration/Hangar Building; Roof
Equipment Tag: NA
Year Installed: 2007
Expected Useful Life (Yrs): 15
Remaining Useful Life (Yrs) 4
Priority: 4: Miscellaneous (Further Investigation Required)
Quantity/Unit of Measure: 200/SF
Estimate:
Deficiency Description: There are areas of ponding on the flat roof.
Description of Work: Additional investigation is required to determine source of ponding.

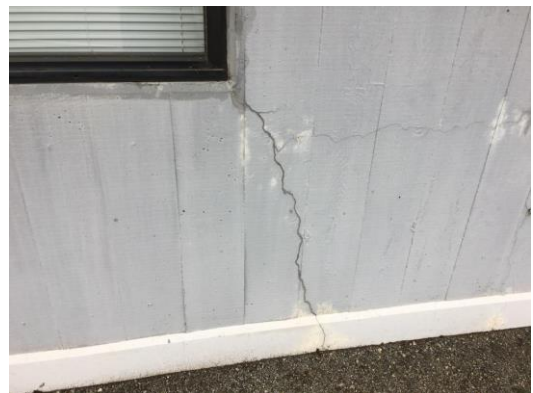
Building Name; Room or Area: Administration/Hangar Building; Exterior Wall
Equipment Tag: NA
Year Installed: 1977
Expected Useful Life (Yrs): 45
Remaining Useful Life (Yrs) 5
Priority: 2: CRITICAL (Address in Years 2 to 5)
Quantity/Unit of Measure: 150/LF
Estimate: \$2,500
Deficiency Description: Cracks on exterior concrete panels near doors and windows.
Description of Work: Replace caulking and sealants.

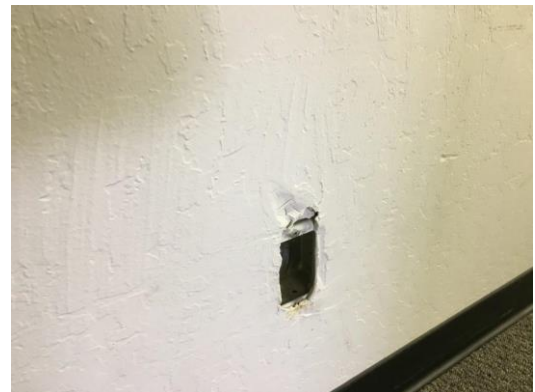
Building Name; Room or Area: Administration/Hangar Building; Leased Space Hallway
Equipment Tag: NA
Year Installed: NA
Expected Useful Life (Yrs):
Remaining Useful Life (Yrs)
Priority: 1: IMMEDIATE (Address in Year 0-2)
Quantity/Unit of Measure: 1/SF
Estimate: \$300
Deficiency Description: Gypsum wallboard has holes, what appears to be a missing electrical outlet.
Description of Work: Patch, prime and paint the affected areas.

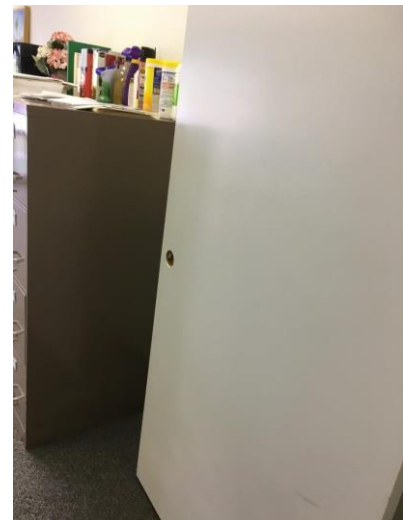
Building Name; Room or Area: Administration/Hangar Building; Leased Space (Admin Office)
Equipment Tag: NA
Year Installed: NA
Expected Useful Life (Yrs):
Remaining Useful Life (Yrs)
Priority: 1: IMMEDIATE (Address in Year 0-2)
Quantity/Unit of Measure: 1/EA
Estimate: \$2,200
Deficiency Description: Door is missing hardware
Description of Work: Install new lever type door handle

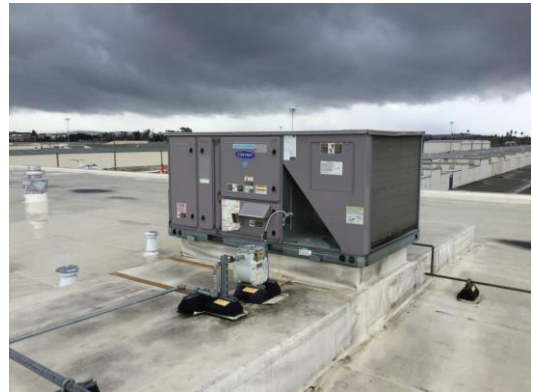
Building Name; Room or Area: Administration/Hangar Building
Equipment Tag: Package AC AC-2
Year Installed: 2007
Expected Useful Life (Yrs): 18
Remaining Useful Life (Yrs) 7
Priority: 3: RECOMMENDED (Address in Years 5 to 10)
Quantity/Unit of Measure: 1/EA
Estimate: \$44,300
Deficiency Description: *Rooftop/ground mounted packaged DX AC unit (3-ton to 8-ton) is at or approaching the end of its useful life.*
Description of Work: *Provide equipment replacement and installation.*

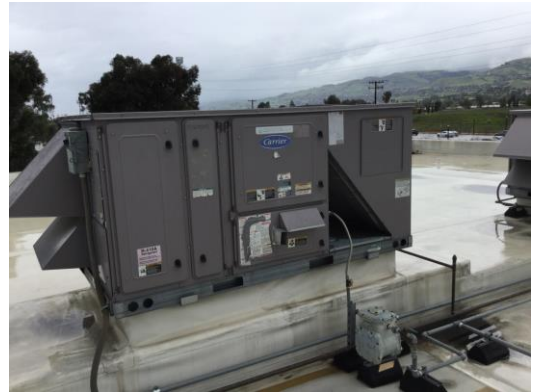
Building Name; Room or Area: Administration/Hangar Building
Equipment Tag: Package AC AC-4
Year Installed: 2007
Expected Useful Life (Yrs): 18
Remaining Useful Life (Yrs) 7
Priority: 3: RECOMMENDED (Address in Years 5 to 10)

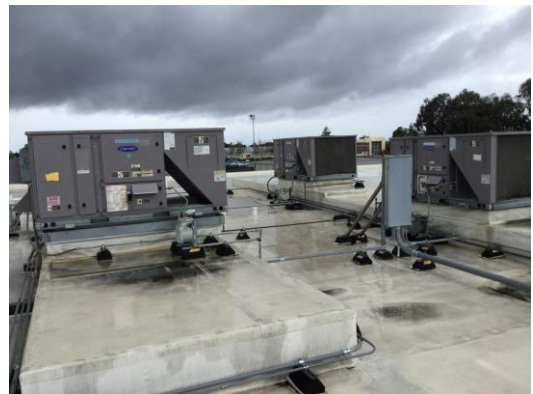
Building Name; Room or Area: Administration/Hangar Building
Equipment Tag: Thrrmostat
Year Installed: 2007
Expected Useful Life (Yrs): 20
Remaining Useful Life (Yrs) 9
Priority: 3: RECOMMENDED (Address in Years 5 to 10)

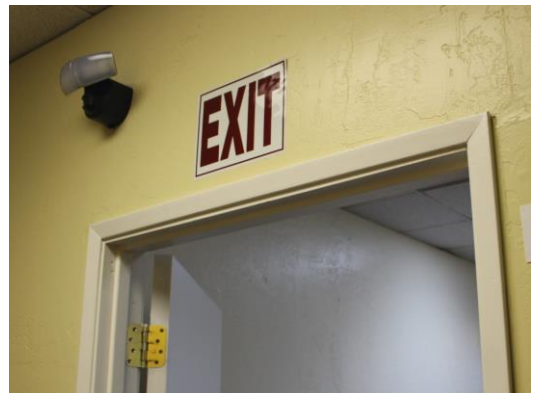
Building Name; Room or Area: Administration/Hangar Building; Exits
Equipment Tag: Exit Signs
Year Installed: NA
Expected Useful Life (Yrs):
Remaining Useful Life (Yrs):
Priority: 1: IMMEDIATE (Address in Year 0-2)
Quantity/Unit of Measure: 5/EA
Estimate: \$6,300
Deficiency Description: *Public areas do not have code required illuminated exit lights.*
Description of Work: *Add battery backed up illuminated exit lights including the necessary circuitry.*

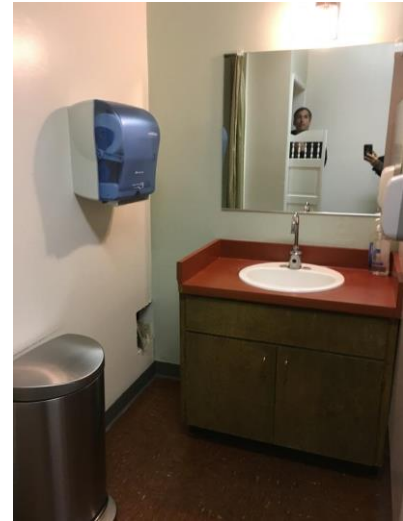
Building Name; Room or Area: Administration/Hangar Building; Women's Restroom
Equipment Tag: NA
Year Installed: NA
Expected Useful Life (Yrs): NA
Remaining Useful Life (Yrs)
Priority: 1: IMMEDIATE (Address in Year 0-2)
Quantity/Unit of Measure: 160/SF
Estimate: \$171,700
Deficiency Description: *Inadequate or non-existent ADA restrooms.*
Description of Work: *Provide a new disabled accessible single occupant restroom.*

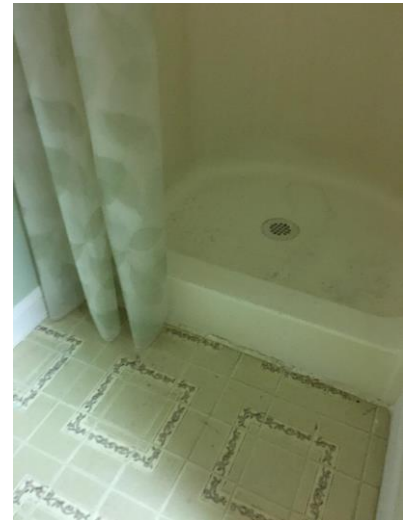
Building Name; Room or Area: Administration/Hangar Building; Shower in Women's Restroom
Equipment Tag: NA
Year Installed: NA
Expected Useful Life (Yrs): NA
Remaining Useful Life (Yrs)
Priority: 1: IMMEDIATE (Address in Year 0-2)
Quantity/Unit of Measure: 16/SF
Estimate: \$6,500
Deficiency Description: *Showers are not accessible.*
Description of Work: *Remodel existing shower(s) to comply with ADA requirements.*

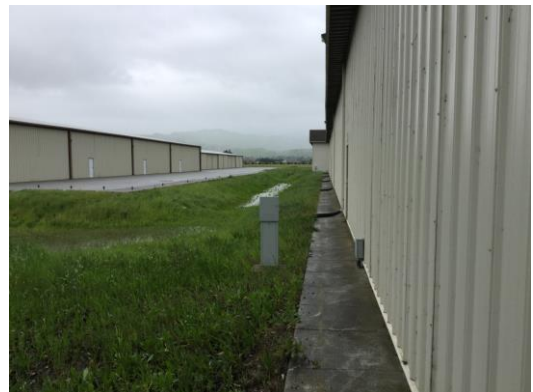
Building Name; Room or Area: Hangar Building
Equipment Tag: Rainwater Drain
Year Installed: 2005
Expected Useful Life (Yrs):
Remaining Useful Life (Yrs)
Priority: 1: IMMEDIATE (Address in Year 0-2)
Quantity/Unit of Measure: 24/LF
Estimate: \$2,000
Deficiency Description: (E) Downspout drain line does not extend and drain away from building causing use of a temporary drain line on walkway creating a trip hazard.
Description of Work: Extend roof/downspout drain underground to curb/daylight.

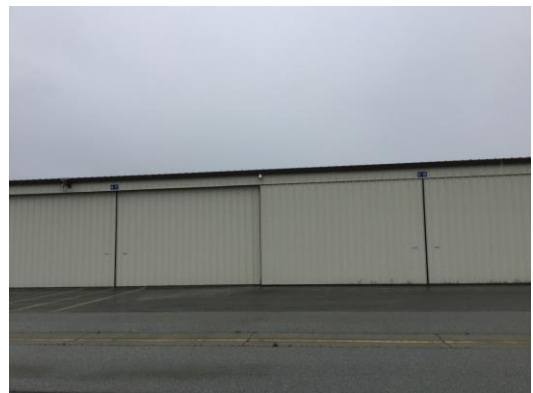
Building Name; Room or Area: Hangar Building
Equipment Tag: Rainwater Drain
Year Installed: 2005
Expected Useful Life (Yrs):
Remaining Useful Life (Yrs)
Priority: 3: RECOMMENDED (Address in Years 5 to 10)
Quantity/Unit of Measure: 48/LF
Estimate: \$2,400
Deficiency Description: Downspouts are not extended away from building causing rainwater in building.
Description of Work: Extend downspout drain away from building.
