## MEMORANDUM

From: SCAPA Lead Task Force

April 20, 2015

RE: EPA LEAD MONITORING AT THE SAN CARLOS AIRPORT (KSQL)

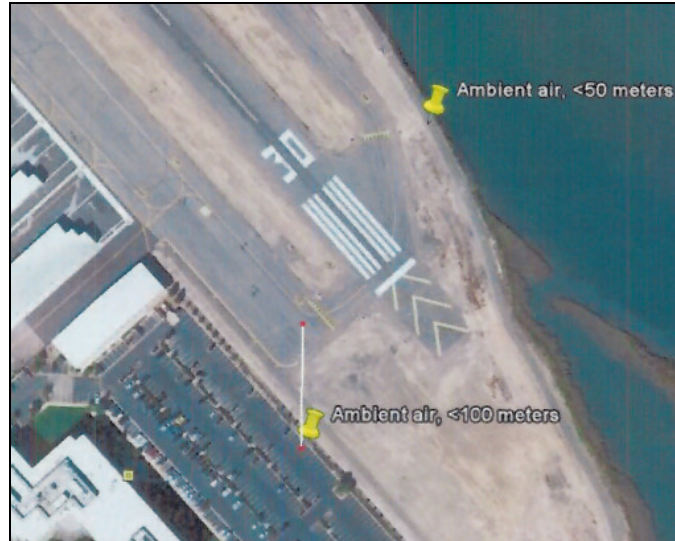
**Figure 1 - Study Design Monitor Placement**

The EPA Memo also included discussion of the proposed study at each airport, including aerial photographs showing the site for the air monitors. For KSQL, the photo<sup>6</sup> (see Figure 1, below) shows two monitors—one located on the north (Bay) side of runway 30, and one outside the security fence on the south side of runway 30.

The monitor on the north side was to be placed “less than 50 meters” from the runway 30 runup area and threshold. Because there is no public access to the north side of runway 30, SCAPA objected to the placement of a monitor in that location. That monitor location was eliminated from the study. The monitor on the south side was to be placed at the location shown by the pin in Figure 1.

The security fence around the run-up area disperses some of prop blast. Moving the monitors outside the security fence and closer to the Bay (where originally proposed) would provide readings that represent the air in a publicly accessible area.

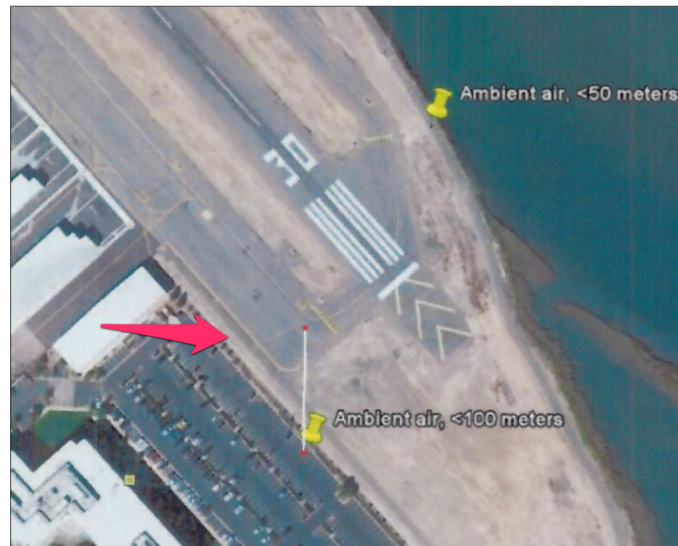
**Figure 2 - Actual Monitor Placement (Red Arrow Location)**

That, however, is *not* where EPA put the monitor. Instead of placing the monitor downwind from the runup area (where pilots exercise their engines to a high RPM to ensure proper performance and safety during take-off and thereafter) on the south side of 30, EPA mounted the monitor inside the security fence directly behind the run-up area—25 or fewer feet from the aircraft exhaust, and DIRECTLY in the propeller blast of the engines. See Figures 2 and 3, below. The prop blast easily overwhelms prevailing winds, and blows engine exhaust directly behind the airplanes, into the monitor, before the blast reaches the security fence that separates the runup area from the parking lot.<sup>7</sup> Pedestrians are prohibited inside of the security fence.<sup>8</sup> Even if pedestrians were permitted access, prop blast from aircraft engines at idle is significant, uncomfortable to endure, and during engine runup, highly uncomfortable and dangerous—blowing dust, sand, gravel with force sufficient to cause injury. People

do not voluntarily stand in or breathe prop blast. In EPA’s lexicon, the monitors are not located in or sampling “ambient air”. Moreover, the monitor manufacturer’s operating manual prohibits sampling in a direct blast of air (such as “prop blast” – the forceful wind from an aircraft’s propeller), in non-ambient air conditions. Thus, the conditions under which the EPA’s monitor data was taken at KSQL – in prop blast - was patently invalid.<sup>9</sup>

2. Thereafter, reposition the monitors to ensure that they sample ambient air in a publically accessible area rather than in localized concentrations of engine emission in prop wash.

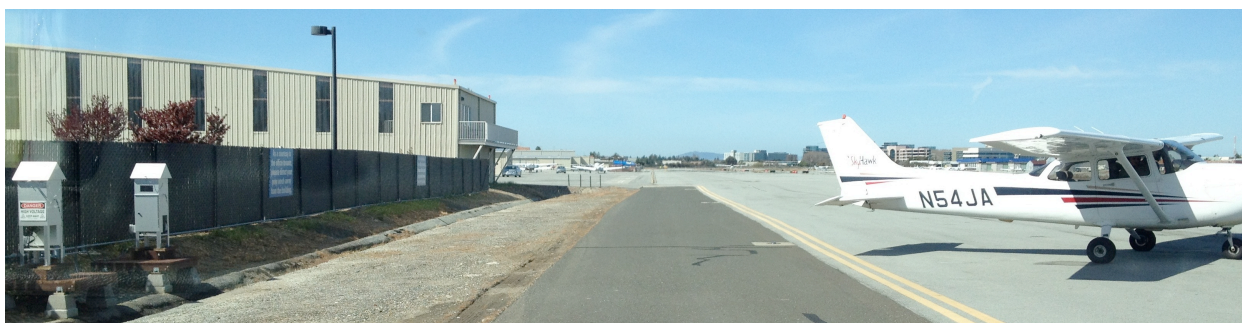
**Figure 3 - Monitor Proximity to Run-up Area – In the Prop Blast ~25'**

The force of the prop blast, however, dissipates quickly. The security fence itself, because it has slats in it, substantially arrests and deflects the prop blast. This fact is readily observable by standing behind the fence line, where the air velocity in the parking lot is dramatically less than the velocity on the other side of the security fence immediately behind the aircraft. Indeed, the security fence and environs show how the security fence absorbs tremendous amounts of energy from prop blast during runup. Once deflected, engine exhaust disperses and follows the prevailing winds away from the parking lot and towards the Bay.
