County of Santa Clara
Roads and Airports Department

SUBJECT: Monthly Reporting of 2022/2023 Winter Storm Damage Repairs
Futures ID#2023-090

Attachment B

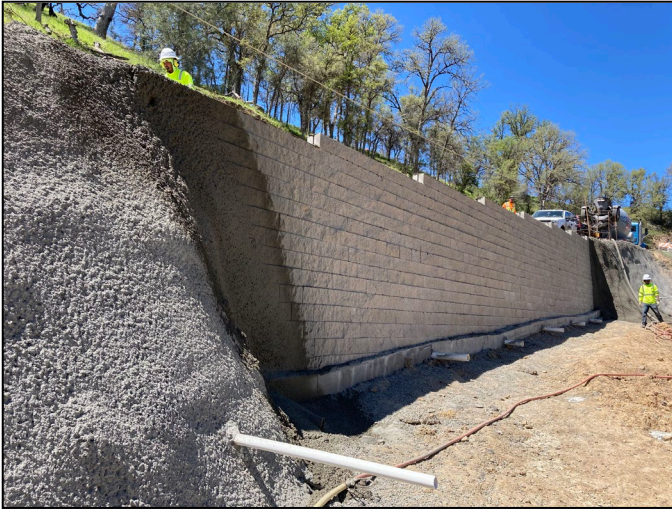
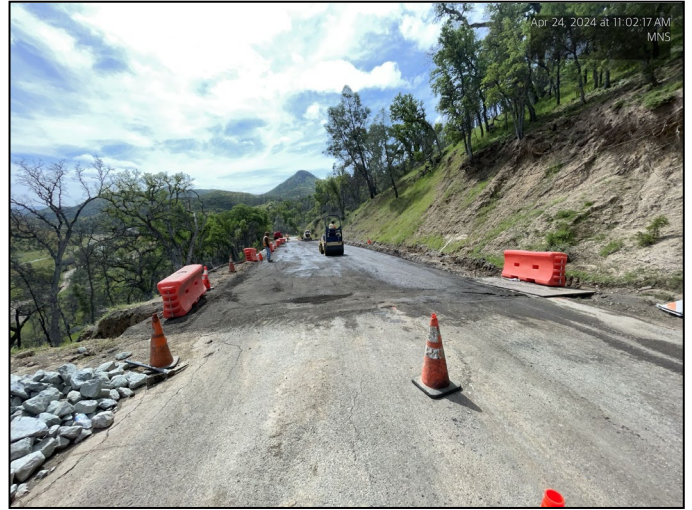
A 70-foot-long section of road shoulder failed. The construction of a retaining structure, approximately 13 feet tall is required to build back the roadway. Safety guardrails to follow.

Repairs

- **San Antonio Valley Road Site 5** – Construction of retaining structure is complete and new roadbed construction is underway. It is anticipated that work will be substantially completed in early May.

12	P	San Antonio Valley Road Site 5	16 Miles SE of Alum Rock Ave	100%	100%	75%	Construction of retaining structure substantially complete. Construction of new roadbed underway.
13	P	Aldercroft Heights Site 2	1 Mile SE of Old Santa Cruz Hwy	100%	0%	0%	Department has commenced negotiations with an engineering firm to develop engineered plans and provide environmental permitting support.
14	F	Old Santa Cruz Hwy Site 1	0.4 Miles NW of Idylwild Rd	100%	98%	0%	Complete JO with Wattis, NTP for Site to follow with Construction of temporary access completion anticipated by end of May '24
15	P	Bear Creek Road Site 2	1.5 Miles SW of HWY 17	100%	0%	0%	Further Site review needed prior to development of engineered plans and construction documents (Permanent repair and completion pending required permitting, winterization and stabilization to be completed in the interim)
16	P	Aldercroft Heights Site 1	Just N of Old Santa Cruz Hwy	100%	0%	0%	Single lane access restored, winterization complete. (Permanent repair and completion pending required permitting and permanent design review)

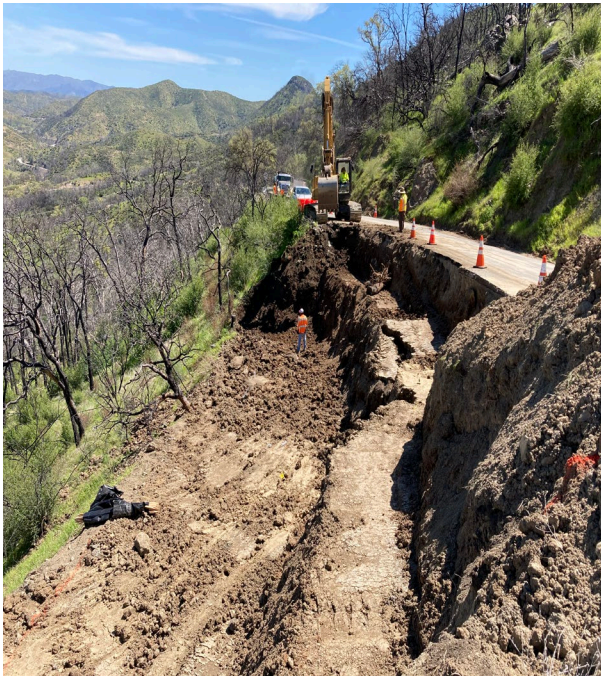
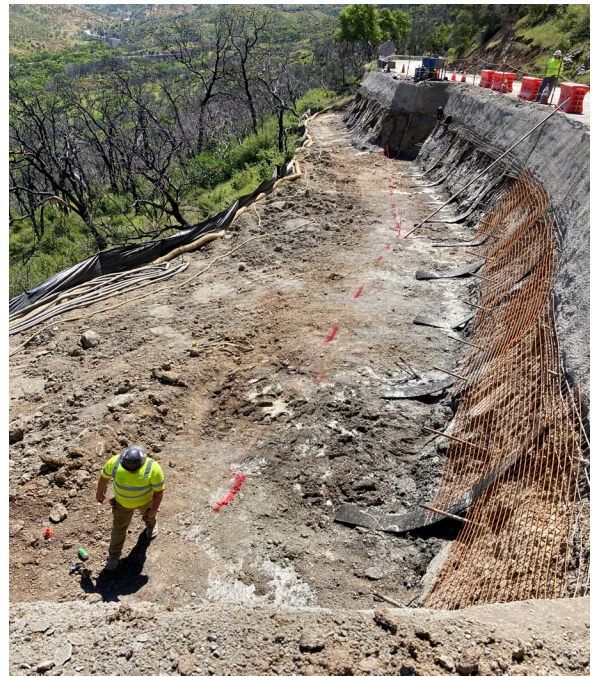
An approximately 200-foot-long section of road shoulder failed. The construction of a retaining structure, approximately 15 feet tall is required to build back the roadway. Safety guardrails to follow.

Repairs

- **San Antonio Valley Road Site 4** – Site preparation commenced in early April, Construction of retaining structure underway. It is anticipated that work will be substantially completed in late May.

6	P	San Antonio Valley Road Site 3	13 Miles SE of Alum Rock Ave	100%	100%	98%	Construction substantially complete, touch up paving and striping to be done weather permitting, cleanup and closeout to follow
7	O	Mines Road Site 1	5.5 Miles N of San Antonio Valley Rd	100%	100%	100%	Construction complete, final striping to be done by County forces
8	O	Mines Road Site 2	6 Miles N of Mt Hamilton Rd (Hwy 130)	100%	100%	100%	Construction complete, final striping to be done by County forces
9	P	San Antonio Valley Road Site 1	15 Miles SE of Alum Rock Ave	100%	100%	98%	Construction substantially complete, cleanup and closeout to follow
10	P	San Antonio Valley Road Site 2	15 Miles SE of Alum Rock Ave	100%	100%	98%	Construction substantially complete, touch up paving and striping to be done weather permitting, cleanup and closeout to follow
11	P	San Antonio Valley Road Site 4	15 Miles SE of Alum Rock Ave	100%	100%	30%	Construction ongoing, Micropile installation underway.
