Community Meeting MacArthur Avenue

October 16, 2019

MacArthur Avenue Limits and Project Study Area

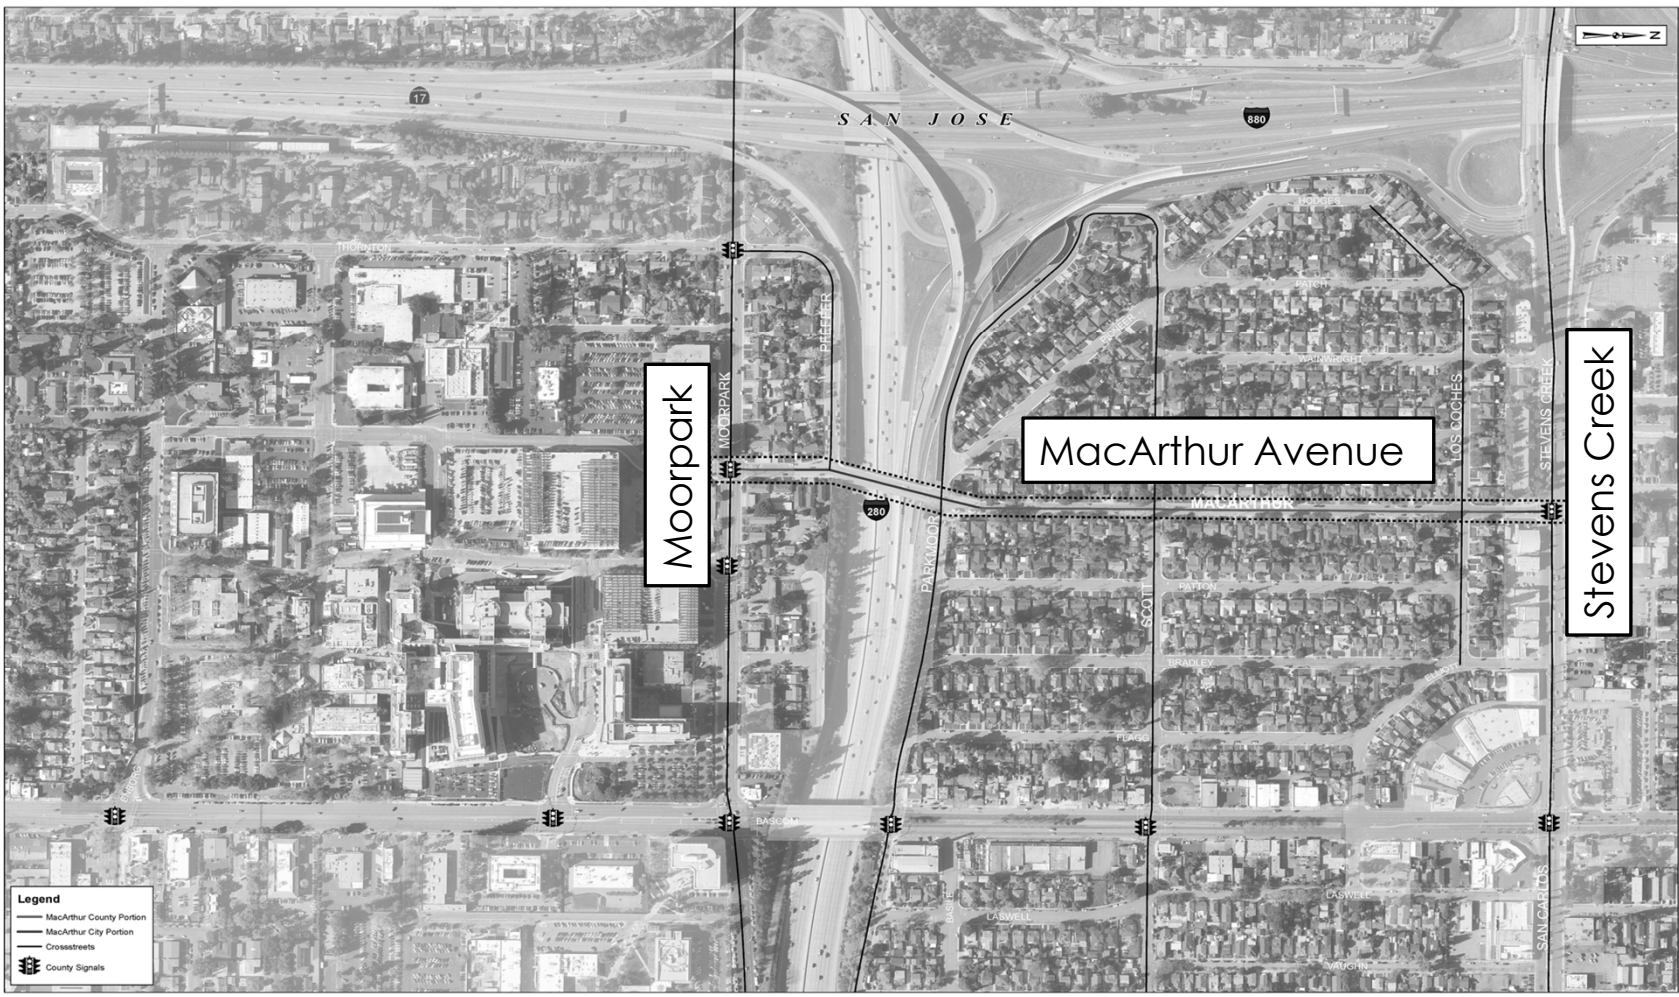
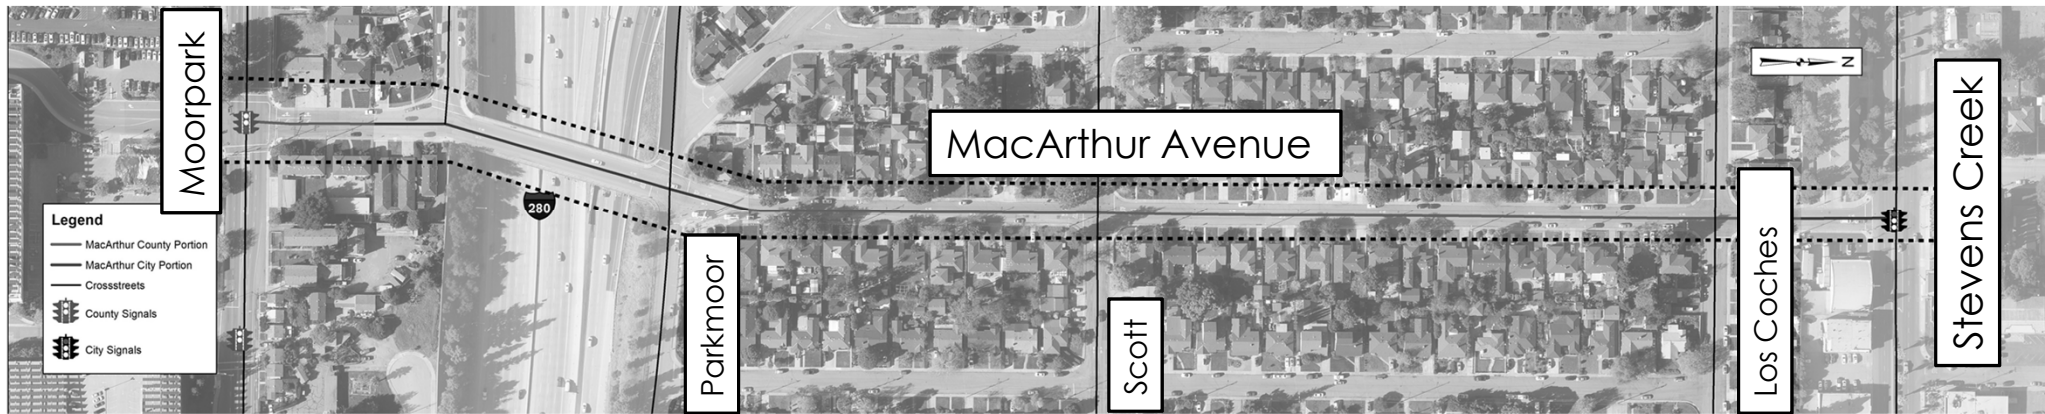
- ½ mile corridor connecting residential, hospitals, and commercial districts
- City of San Jose/County shared jurisdiction
- MacArthur Avenue identified as bicycle route with “sharrows”
- Two signalized and two all-way stop intersections

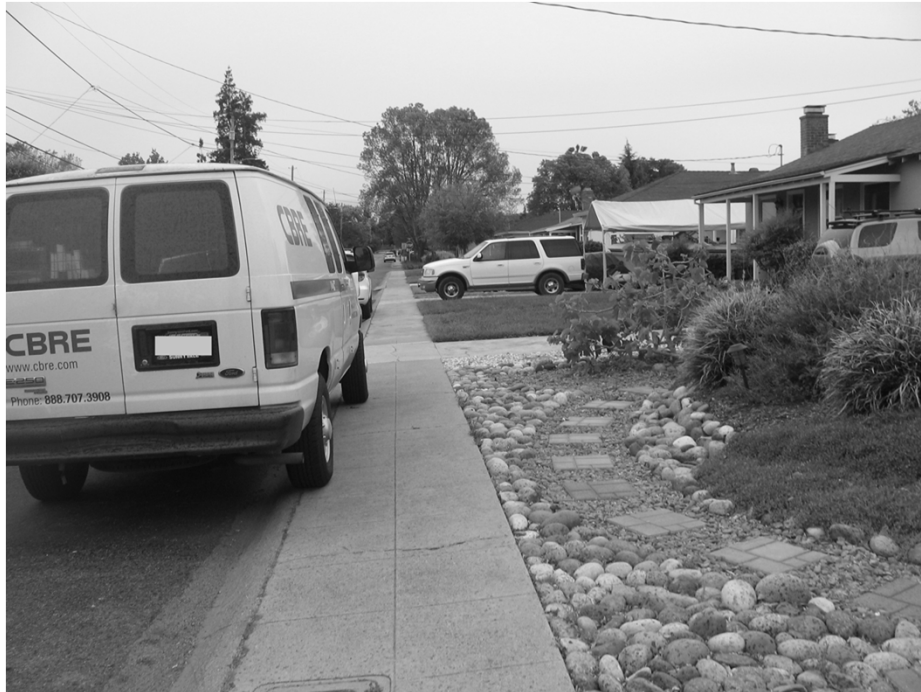
Before

Shoulder lines were added to guide parking

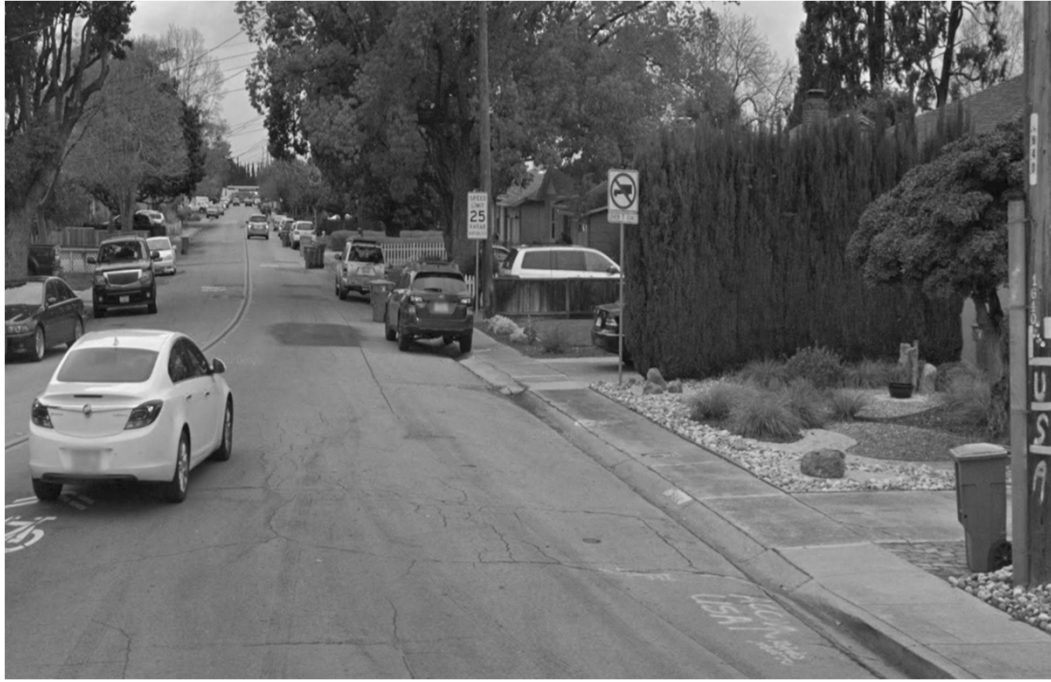
Before

Travel lane was narrowed to 10' in each direction

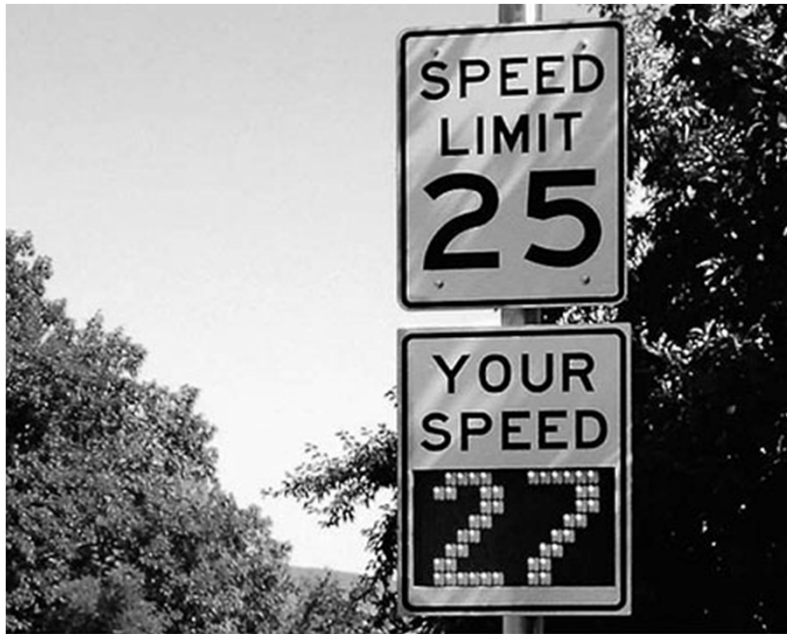
Dynamic Speed Feedback Signs

Pros: Increases speed awareness, no impact to resident parking, no impacts to emergency response, no noise increase

Cons: Increased maintenance

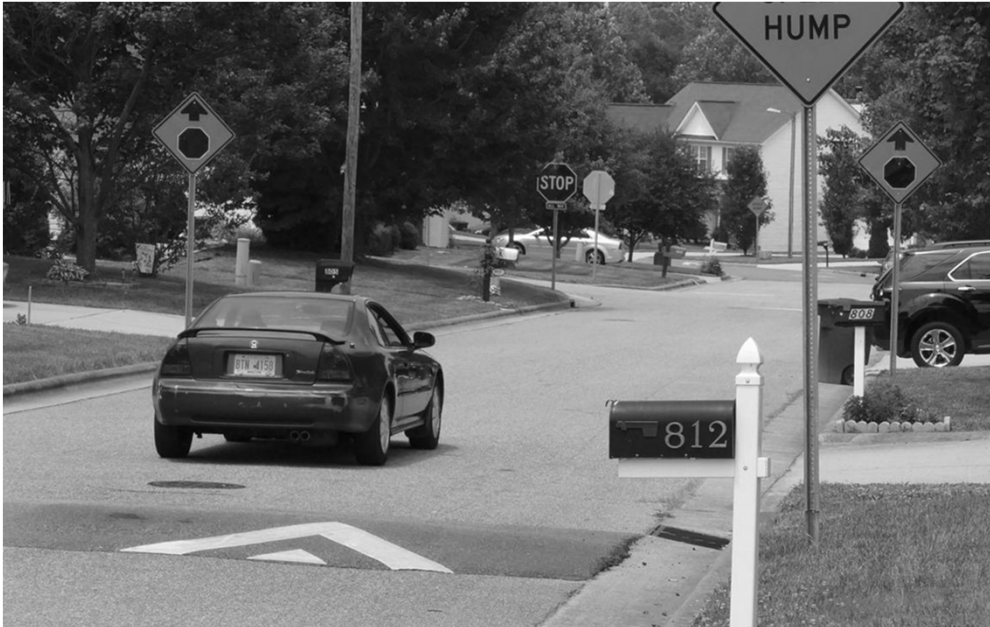
Speed Hump

Pros: Reduces speed at speed hump location

Cons: Noise, Higher speeds downstream of speed hump, emergency response may be delayed

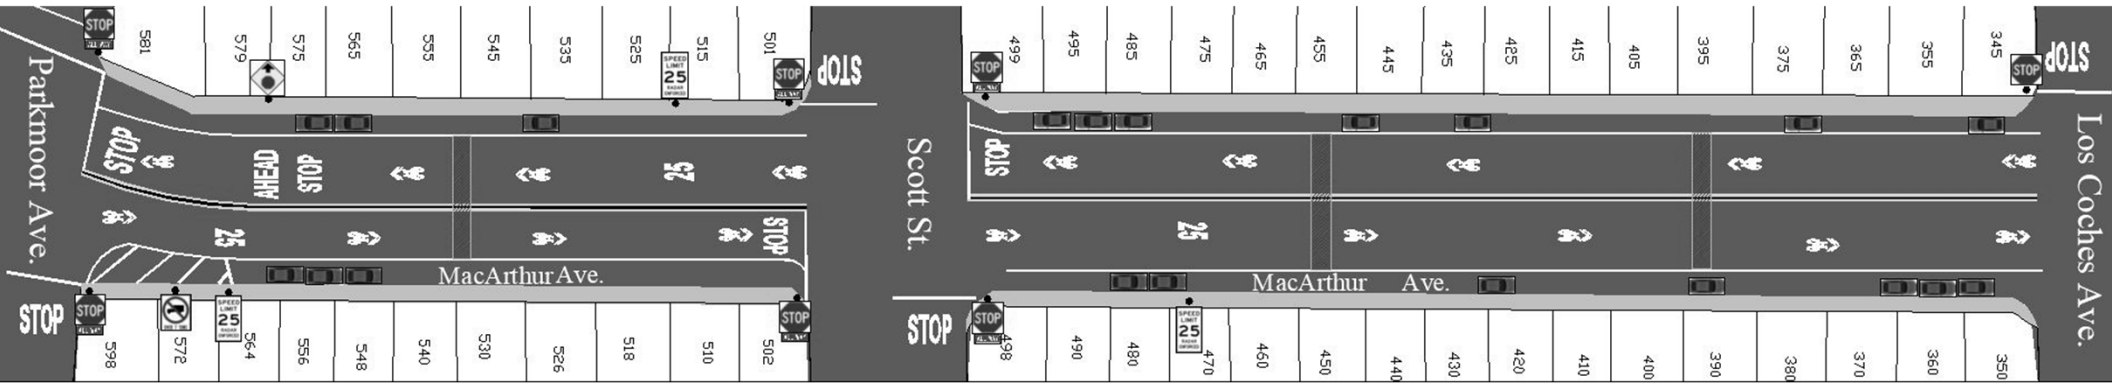
Approximate Locations of Speed Humps

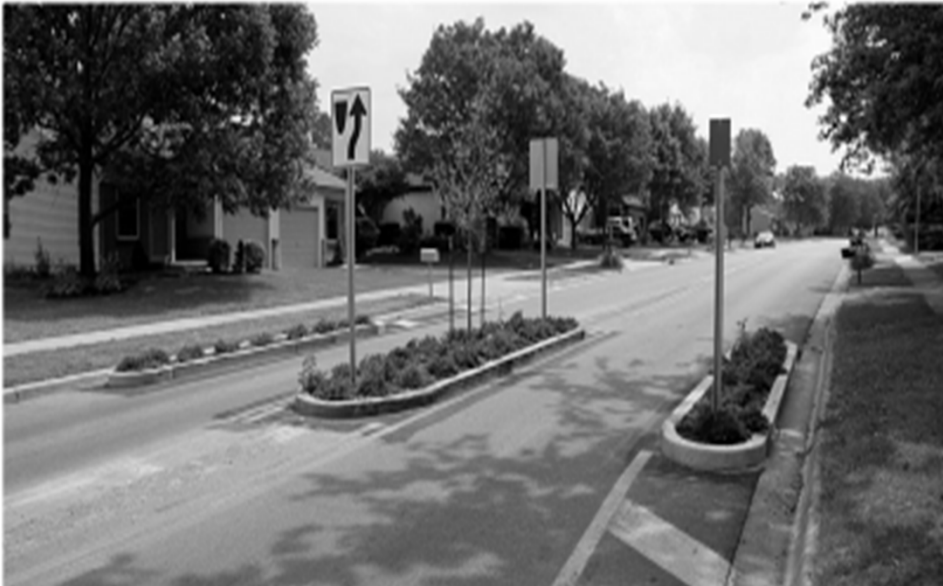
Chokers

Pros: Narrowed roadway section may reduce speeds

Cons: Loss of some on-street parking, High cost to construct and maintain, may increase traffic collision, emergency response may be delayed
