Facility Condition Assessment Report Santa Clara County Airports

*Prepared by Kitchell
For*

County of Santa Clara, California

Reid Hillview Airport Terminal Building Facility Condition Assessment

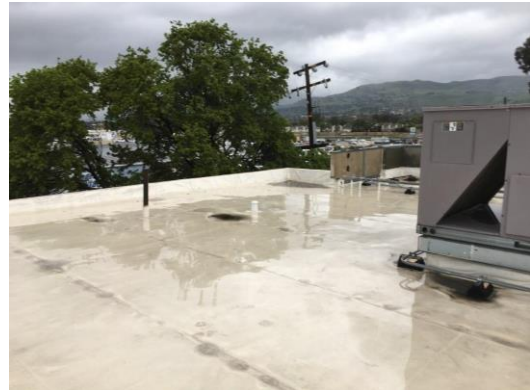
Building Name; Room or Area: Administration/Terminal Building; Roof
Equipment Tag: NA
Year Installed: 2007
Expected Useful Life (Yrs): 15
Remaining Useful Life (Yrs) 4
Priority: 2: CRITICAL (Address in Years 2 to 5)
Quantity/Unit of Measure: 5,700/SF
Estimate: \$331,800
Deficiency Description: PVC roof is at or approaching the end of its useful life.
Description of Work: Remove existing roof and replace one for one.

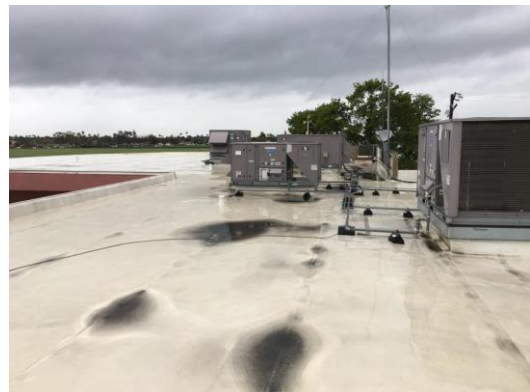
Building Name; Room or Area: Administration/Terminal Building; Roof
Equipment Tag: NA
Year Installed: 2007
Expected Useful Life (Yrs): 15
Remaining Useful Life (Yrs) 4
Priority: 4: Miscellaneous (Further Investigation Required)
Quantity/Unit of Measure: 500/SF
Estimate:
Deficiency Description: There are areas of ponding on the flat roof.
Description of Work: Additional investigation is required to determine source of ponding.

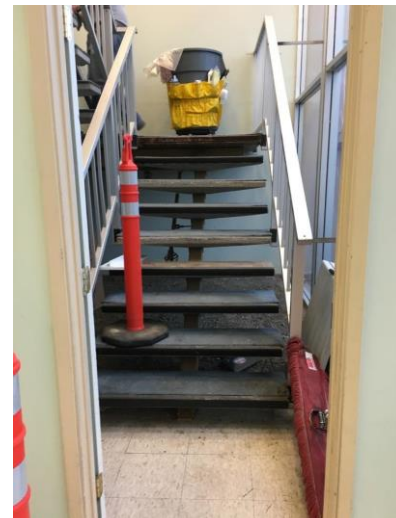
Building Name; Room or Area: Administration/Terminal Building; Interior Stairway
Equipment Tag: NA
Year Installed: 1970
Expected Useful Life (Yrs): 40
Remaining Useful Life (Yrs) 1
Priority: 1: IMMEDIATE (Address in Year 0-2)
Quantity/Unit of Measure: 2/FLT
Estimate: \$154,500
Deficiency Description: Entire interior steel stairway is at or approaching the end of its useful life.
Description of Work: Replace entire interior steel stairway.

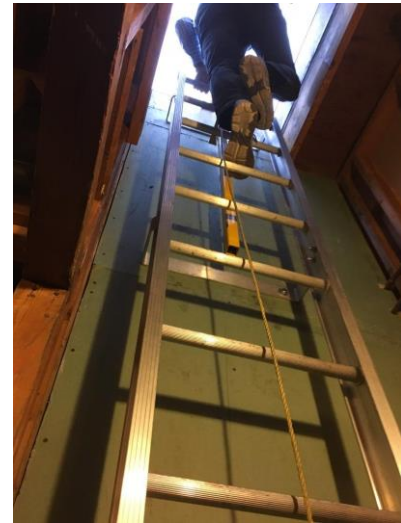
Deficiency Description: *There is no fall protection at roof hatch.*

Description of Work: *Provide fall protection.*

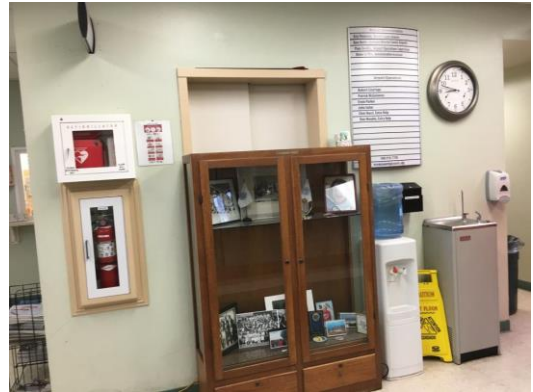
Quantity/Unit of Measure: 1/EA
Estimate: \$476,200
Deficiency Description: *The existing 2-stop elevator is partially removed and not in use.*

Description of Work: *Remove the existing elevator in its entirety and replace it with a new 2-stop hydraulic elevator.*

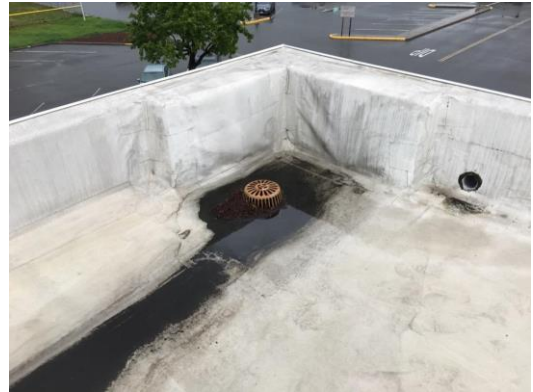
Quantity/Unit of Measure: 2/EA
Estimate: \$2,200
Deficiency Description: *Overflow roof drains are too high.*

Description of Work: *Lower overflow roof drains to a maximum of 2" above roof drains.*

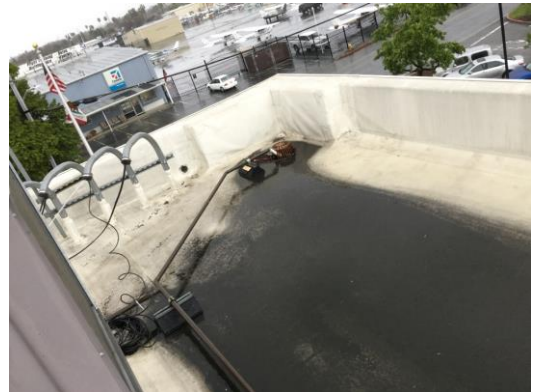
Quantity/Unit of Measure: 4/EA
Estimate: \$11,900
Deficiency Description: *Roof drains are damaged and clogged*

Description of Work: *Repair or replace roof drains*

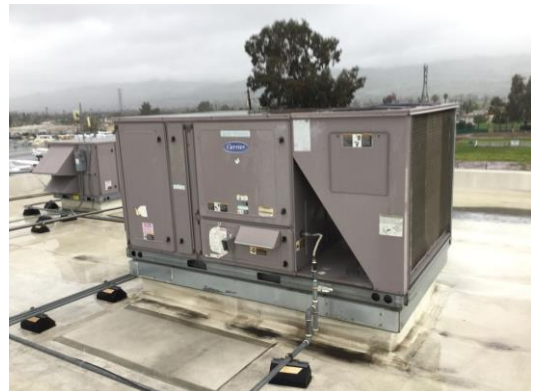
Quantity/Unit of Measure: 1/EA
Estimate: \$74,000
Deficiency Description: *Rooftop/ground mounted packaged DX AC unit (8-ton to 15-ton) is at or approaching the end of its useful life.*

Description of Work: *Provide equipment replacement and installation.*

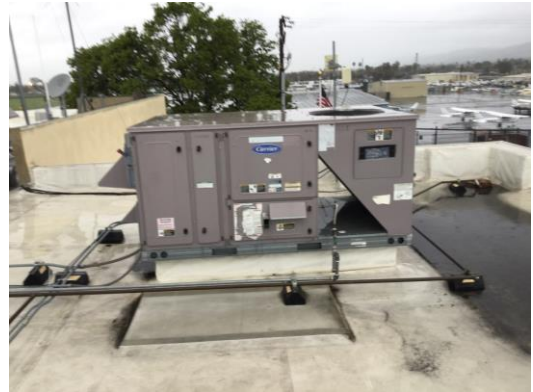
Quantity/Unit of Measure: 1/EA
Estimate: \$44,300
Deficiency Description: Rooftop/ground mounted packaged DX AC unit (3-ton to 8-ton) is at or approaching the end of its useful life.

Description of Work: Provide equipment replacement and installation.

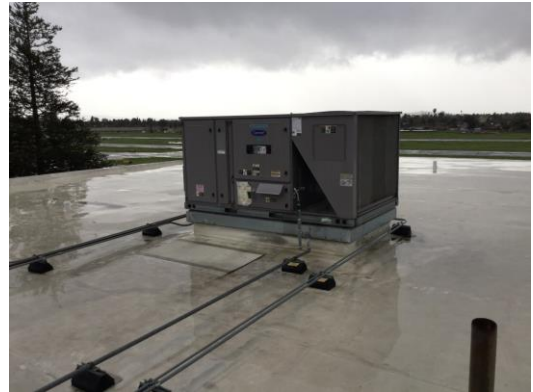
Quantity/Unit of Measure: 1/EA
Estimate: \$74,000
Deficiency Description: Rooftop/ground mounted packaged DX AC unit (8-ton to 15-ton) is at or approaching the end of its useful life.

Description of Work: Provide equipment replacement and installation.

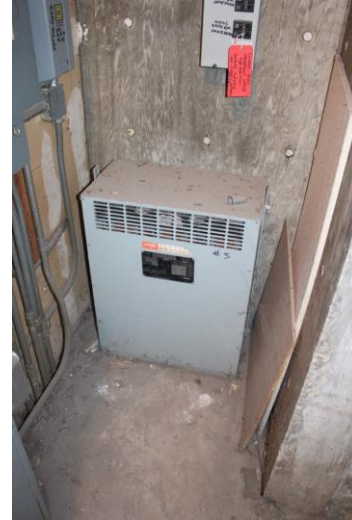
Deficiency Description: *The 50kVA transformer (1P dry-type, 240/480-120/240V) is approaching the end of its expected useful life.*

Description of Work: *Replace the existing transformer with a new transformer.*

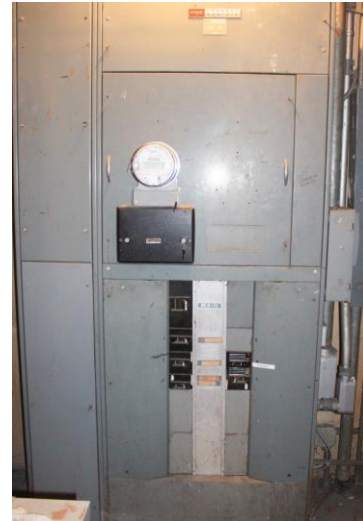
Deficiency Description: *The 400A metered main switchboard (3P, 277/480) is at or approaching the end of its useful life.*

Description of Work: *Replace the existing metered main switchboard with a new metered main switchboard.*

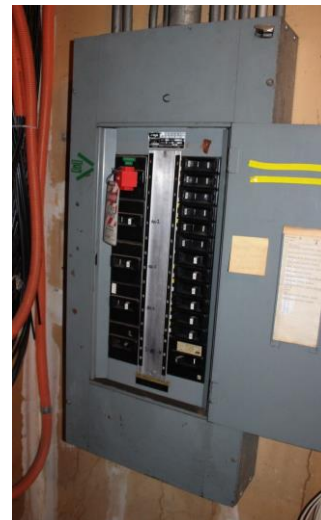
Deficiency Description: *The 225A (42 ckts, 120/240V, 3P) panelboard is at or approaching the end of its useful life.*

Description of Work: *Replace the existing panelboard with a new panelboard.*

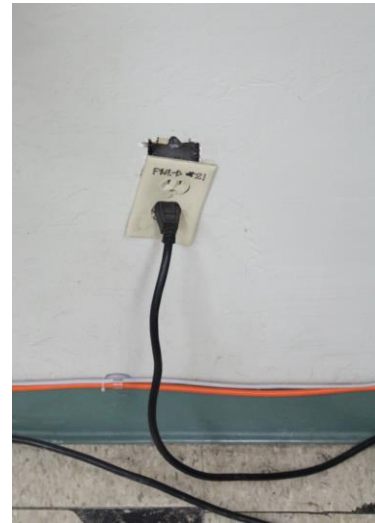
Deficiency Description: *The wiring device (outlet box, junction box, receptacle, etc.) needs to be replaced.*

Description of Work: *Supply and install a new junction box and cover.*

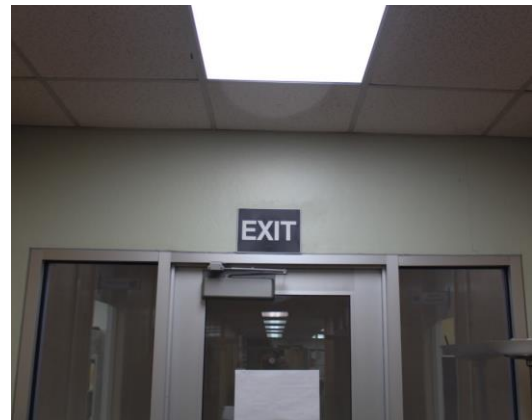
Deficiency Description: *Public areas do not have code required illuminated exit lights.*

Description of Work: *Add battery backed up illuminated exit lights including the necessary circuitry.*

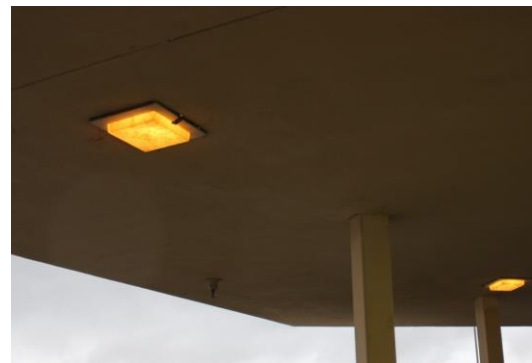
Deficiency Description: *The exterior lighting fixture's lens is yellowing or is in poor condition.*

Description of Work: *Replace the yellowed lighting fixture's lens.*

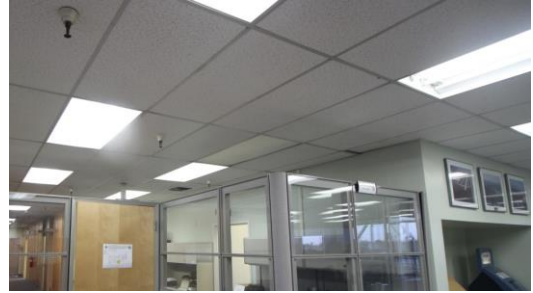
Building Name; Room or Area: Administration/Terminal Building
Equipment Tag: Interior Ltg
Year Installed: 1970
Expected Useful Life (Yrs): 20
Remaining Useful Life (Yrs)
Priority: 1: IMMEDIATE (Address in Year 0-2)
Quantity/Unit of Measure: 90/EA
Estimate: \$46,000
Deficiency Description: 2'W x 4'L three 32 watt T8 grid ceiling mount interior light fixture is damaged or at end of useful life and should be replaced.
Description of Work: Replace the existing interior light fixture with a new interior light fixture.

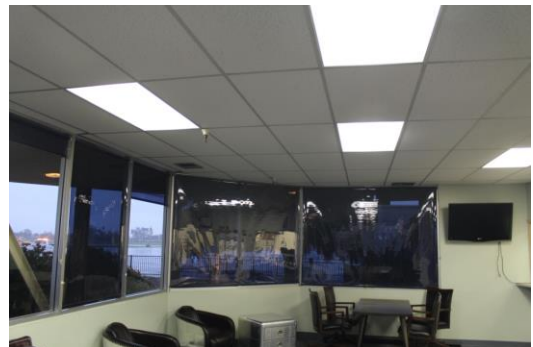
Building Name; Room or Area: Administration/Terminal Building
Equipment Tag: Fire alarm
Year Installed: NA
Expected Useful Life (Yrs):
Remaining Useful Life (Yrs)
Priority: 3: RECOMMENDED (Address in Years 5 to 10)
Quantity/Unit of Measure: 10,120/SF
Estimate: \$223,500
Deficiency Description: The building is not equipped with a fire alarm system or the existing fire alarm system is at the end of its industry rated useful life.
Description of Work: Provide a fully addressable fire alarm control panel with associated initiating and signaling devices.

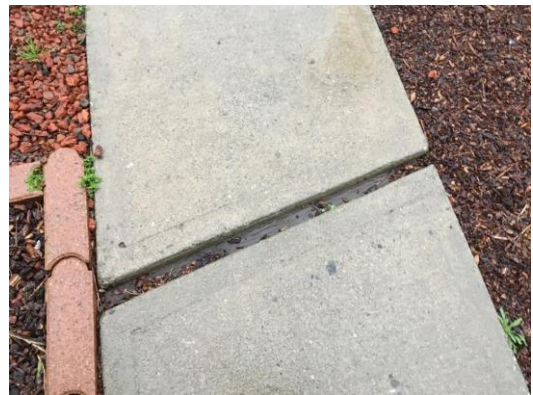
Deficiency Description: Trip hazards are present (> 1 inch).

Description of Work: Repair and replace walkway to remove hazard.

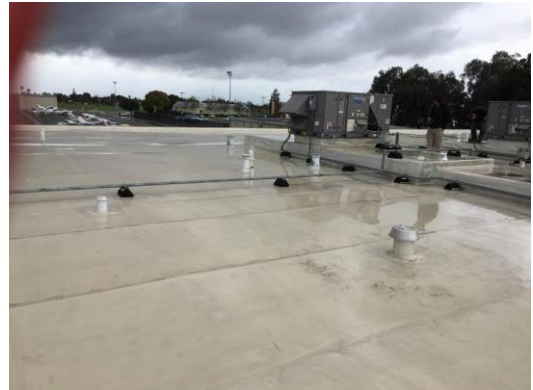
Building Name; Room or Area: Administration/Hangar Building; Roof
Equipment Tag: NA
Year Installed: 2007
Expected Useful Life (Yrs): 15
Remaining Useful Life (Yrs) 4
Priority: 2: CRITICAL (Address in Years 2 to 5)
Quantity/Unit of Measure: 10,500/SF
Estimate: \$611,100
Deficiency Description: PVC roof is at or approaching the end of its useful life.
Description of Work: Remove existing roof and replace one for one.

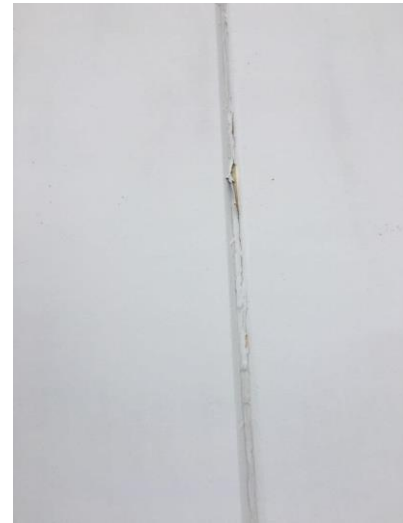
Deficiency Description: At exterior walls: Paint peeling off at tilt up panel joints.

Description of Work: Re-paint all exterior wall surfaces where paint is peeling off. Patch and repair as needed.

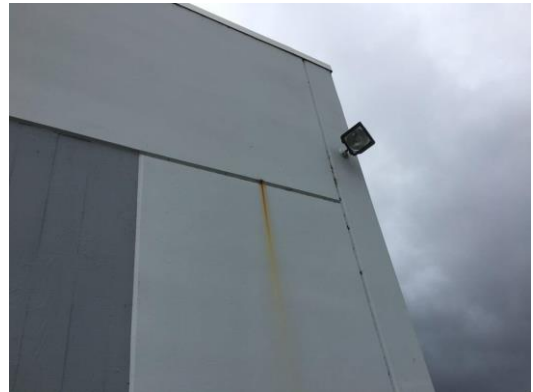
Deficiency Description: Stream of rust water appears to be coming through a small chunk of exterior concrete that has spalled off the wall panel leaving the rebar exposed to the elements.

Description of Work: Further investigation is required.

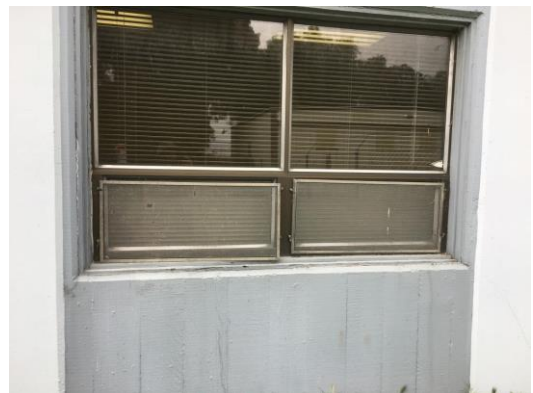
Deficiency Description: The paint finish on the wood window frames is chipped & peeling.

Description of Work: Clean and paint window frames.

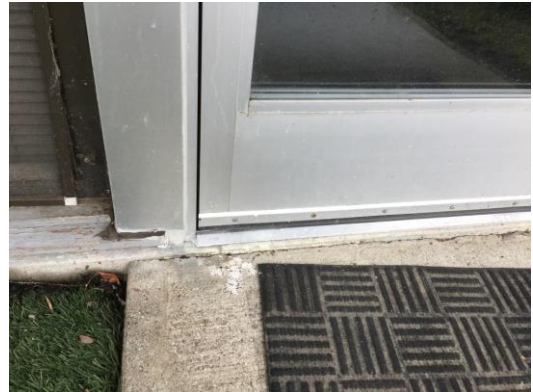
Deficiency Description: Sealant is missing or deteriorated at door frame.

Description of Work: Replace sealant.

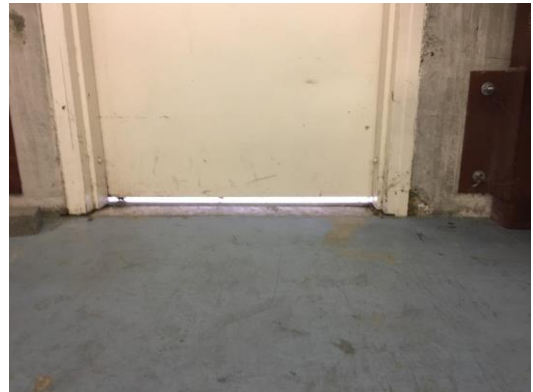
Deficiency Description: Exterior doors leak in wind driven rain.

Description of Work: Provide door bottom sweep, drip cap and overlapping astragal.

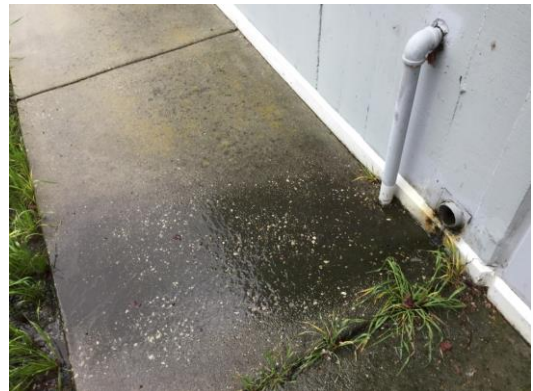
Deficiency Description: (E) Downspout drain line does not extend and drain away from building causing slippery walkway creating a trip hazard.

Description of Work: Extend roof/downspout drain underground to curb/daylight.

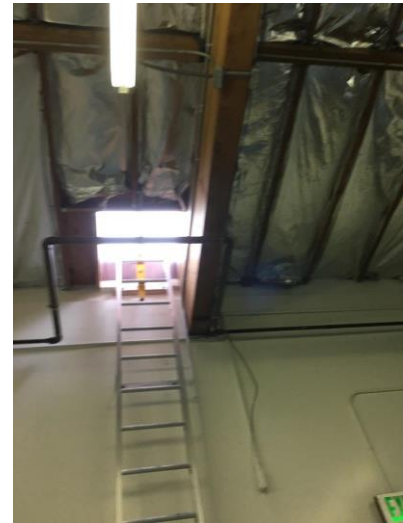
Building Name; Room or Area: Administration/Hangar Building; Roof
Equipment Tag: NA
Year Installed: NA
Expected Useful Life (Yrs):
Remaining Useful Life (Yrs)
Priority: 1: IMMEDIATE (Address in Year 0-2)
Quantity/Unit of Measure: 1/EA
Estimate: \$3,500
Deficiency Description: There is no fall protection at roof hatch.
Description of Work: Provide fall protection.

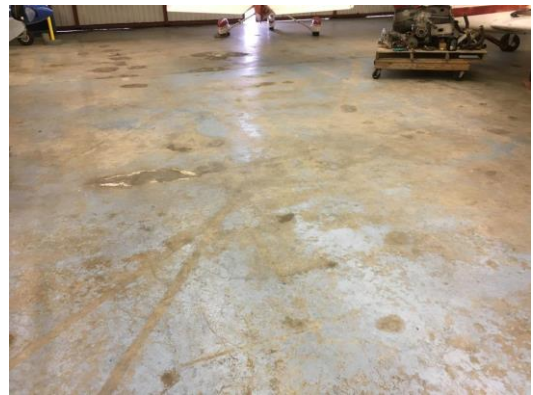
Deficiency Description: Sealed concrete floor is deteriorated

Description of Work: Repair and refinish concrete floor

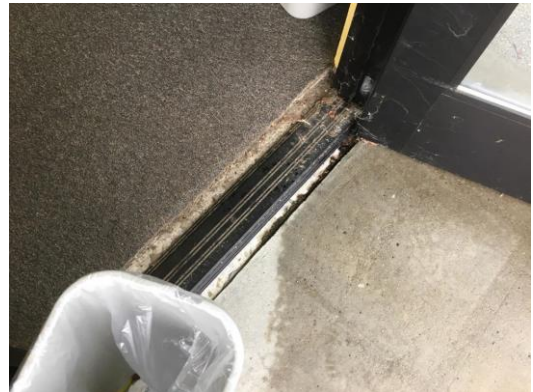
Building Name; Room or Area: Administration/Hangar Building; West Exterior Door

Deficiency Description: Edge of the carpet was not secured to the floor and in poor condition.

Description of Work: Remove the existing carpeting and replace it with new carpet.

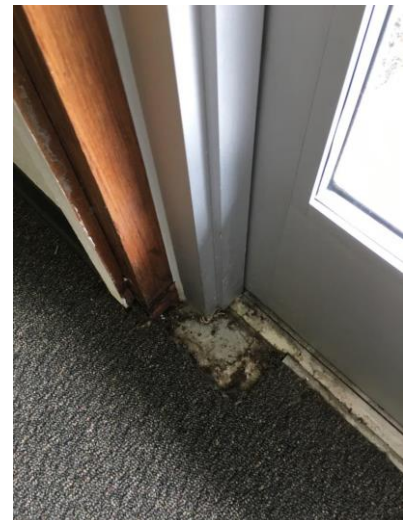
Building Name; Room or Area: Administration/Hangar Building; Leased Space (Open Office Exterior Door)

Deficiency Description: Missing portion of carpet near door and exposed door frames.

Description of Work: Replace portion of carpet and cover frame with gypboard and paint.

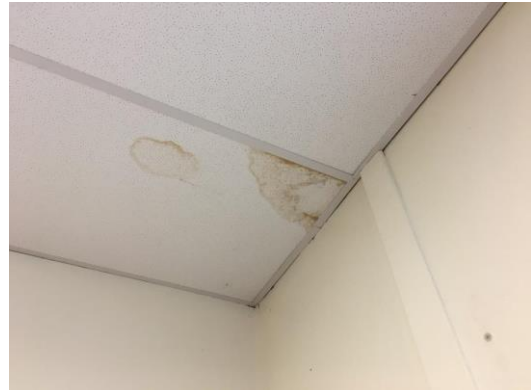
Deficiency Description: Ceiling finish has water damage.

Description of Work: Additional investigation is required to determine source of water damage.

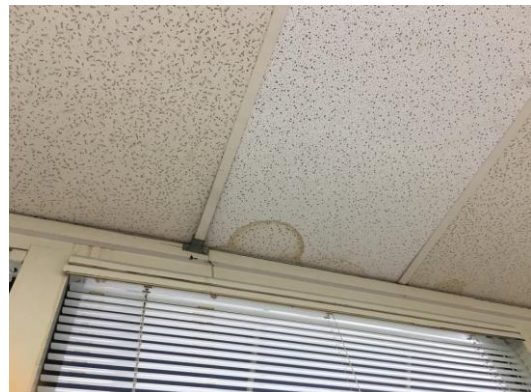
Building Name; Room or Area: Administration/Hangar Building; Leased Space (Admin Office Exterior Window Area)

Deficiency Description: Ceiling finish has water damage.

Description of Work: Additional investigation is required to determine source of water damage.

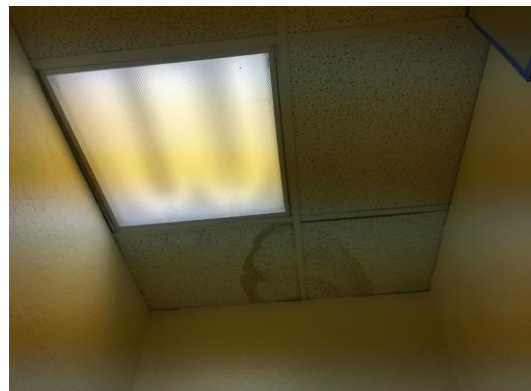
Building Name; Room or Area: Administration/Hangar Building; Telcom Room

Deficiency Description: Existing suspended ceiling grid is at the end of its useful life.

Description of Work: Replace ceiling grid including tiles.

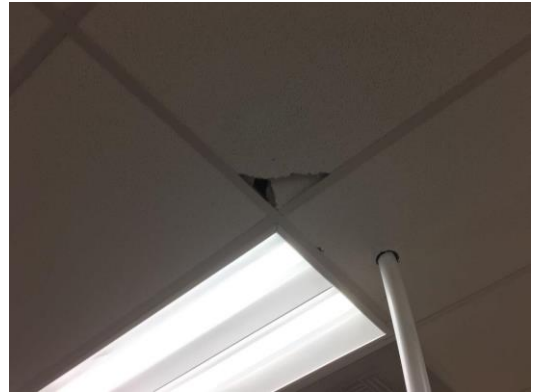
Deficiency Description: Existing suspended ceiling tile is in poor condition.

Description of Work: Replace the existing ceiling tile.

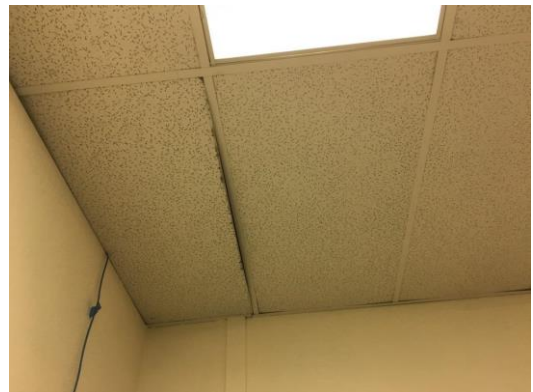
Building Name; Room or Area: Administration/Hangar Building; RHV 130

Deficiency Description: Existing suspended ceiling grid is at the end of its useful life.

Description of Work: Replace ceiling grid including tiles.

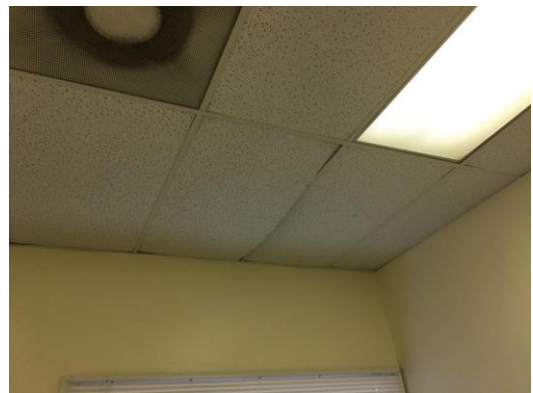
Building Name; Room or Area: Administration/Hangar Building; RHV 135B

Deficiency Description: Existing suspended ceiling grid is at the end of its useful life.

Description of Work: Replace ceiling grid including tiles.

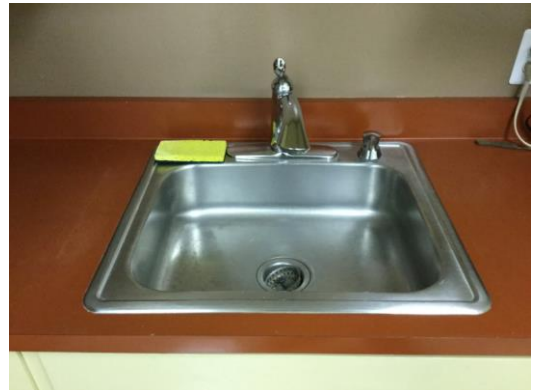
Building Name; Room or Area: Administration/Hangar Building
Equipment Tag: Breakroom Sink
Year Installed: 1977
Expected Useful Life (Yrs): 30
Remaining Useful Life (Yrs): 10
Priority: 3: RECOMMENDED (Address in Years 5 to 10)
Quantity/Unit of Measure: 1/EA
Estimate: \$7,800
Deficiency Description: Single compartment, counter mounted stainless steel sink at or approaching the end of its useful life.
Description of Work: Provide equipment replacement and installation.

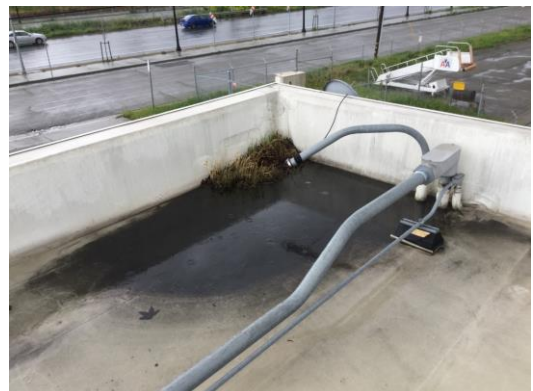
Building Name; Room or Area: Administration/Hangar Building
Equipment Tag: Roof Drain
Year Installed: NA
Expected Useful Life (Yrs):
Remaining Useful Life (Yrs):
Priority: 3: RECOMMENDED (Address in Years 5 to 10)
Quantity/Unit of Measure: 4/EA
Estimate: \$11,900
Deficiency Description: Roof drains are damaged and clogged
Description of Work: Repair or replace roof drains

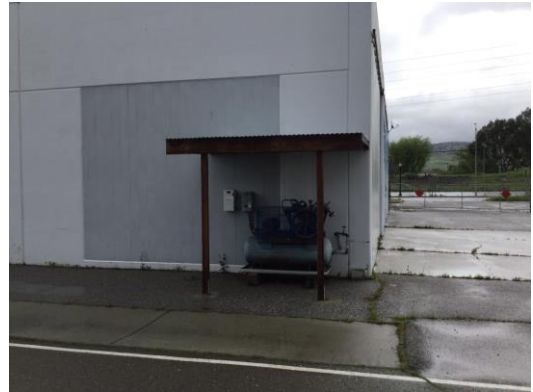
Building Name; Room or Area: Administration/Hangar Building
Equipment Tag: Compressed Air
Year Installed: 1999
Expected Useful Life (Yrs): 15
Remaining Useful Life (Yrs) 6
Priority: 3: RECOMMENDED (Address in Years 5 to 10)
Quantity/Unit of Measure: 1/EA
Estimate: \$4,800
Deficiency Description: *Small air dryer is approaching the end of its expected useful life.*
Description of Work: *Provide equipment replacement and installation.*

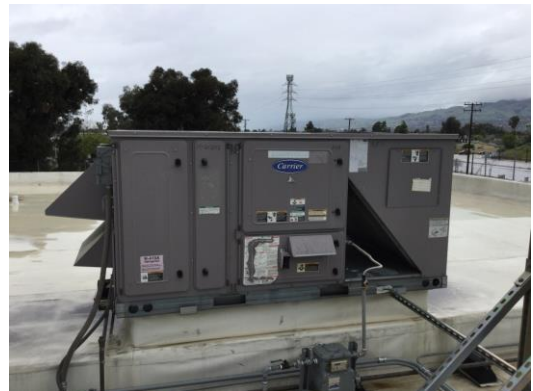
Building Name; Room or Area: Administration/Hangar Building
Equipment Tag: Package AC AC-1
Year Installed: 2007
Expected Useful Life (Yrs): 18
Remaining Useful Life (Yrs) 7
Priority: 3: RECOMMENDED (Address in Years 5 to 10)
Quantity/Unit of Measure: 1/EA
Estimate: \$44,300
Deficiency Description: *Rooftop/ground mounted packaged DX AC unit (3-ton to 8-ton) is at or approaching the end of its useful life.*
Description of Work: *Provide equipment replacement and installation.*

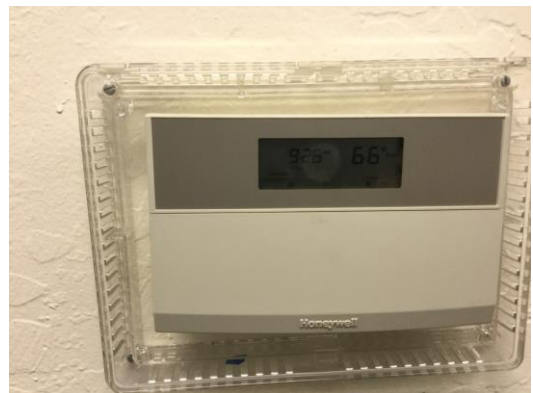
Quantity/Unit of Measure: 4/EA
Estimate: \$2,400
Deficiency Description: Thermostat is at or approaching the end of its useful life.

Description of Work: Provide equipment replacement and installation.

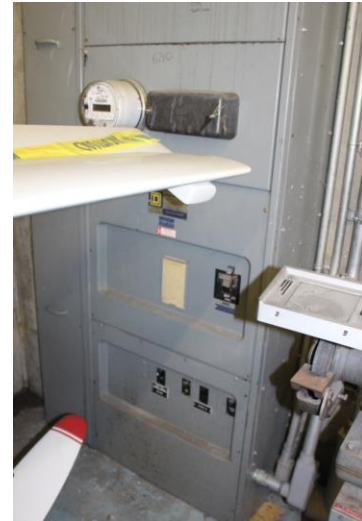
Quantity/Unit of Measure: 1/EA
Estimate: \$12,100
Deficiency Description: The 400A metered main switchboard (3P, 120/208) is at or approaching the end of its useful life.

Description of Work: Replace the existing metered main switchboard with a new metered main switchboard.

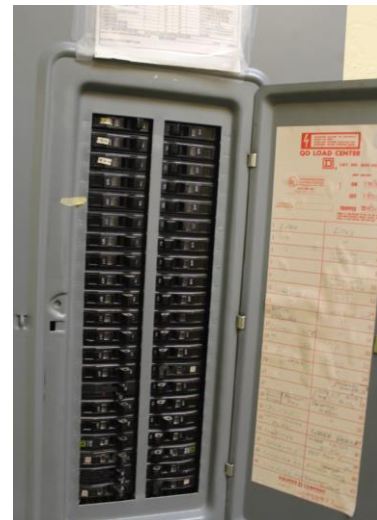
Quantity/Unit of Measure: 3/EA
Estimate: \$36,800
Deficiency Description: The 225A (42 ckts, 120/240V, 3P) panelboard is at or approaching the end of its useful life.

Description of Work: Replace the existing panelboard with a new panelboard.

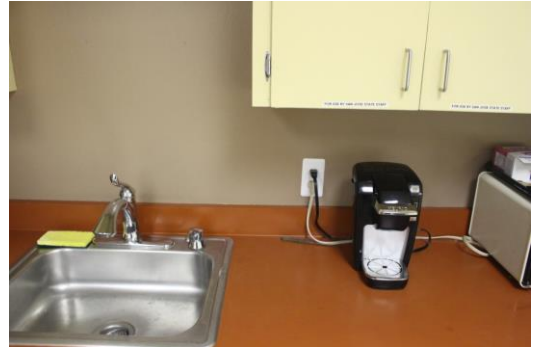
Building Name; Room or Area: Administration/Hangar Building
Equipment Tag: Receptacles
Year Installed: 1977
Expected Useful Life (Yrs): 30
Remaining Useful Life (Yrs):
Priority: 1: IMMEDIATE (Address in Year 0-2)
Quantity/Unit of Measure: 50/EA
Estimate: \$12,500
Deficiency Description: *The receptacle is past its useful life and needs to be replaced.*
Description of Work: *Supply and install a new receptacle.*

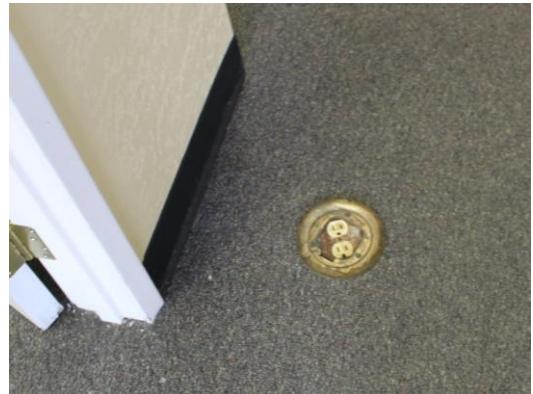
Building Name; Room or Area: Administration/Hangar Building
Equipment Tag: Floor Receptacles
Year Installed: 1977
Expected Useful Life (Yrs):
Remaining Useful Life (Yrs):
Priority: 1: IMMEDIATE (Address in Year 0-2)
Quantity/Unit of Measure: 5/EA
Estimate: \$1,300
Deficiency Description: *The wiring device (outlet box, junction box, receptacle, etc.) needs to be replaced.*
Description of Work: *Supply and install a new floor outlet and cover.*

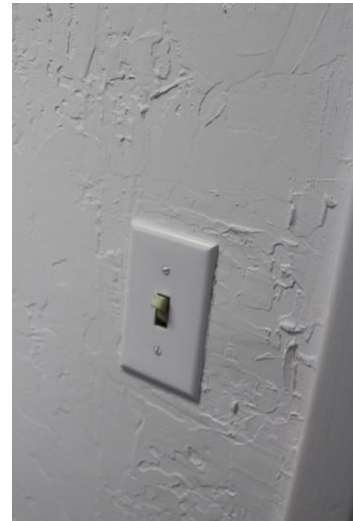
Deficiency Description: Interior lighting control systems are at or are approaching the end of their expected useful lives.

Description of Work: Replace the existing interior lighting associated wiring devices, switches and controls to meet current energy codes.

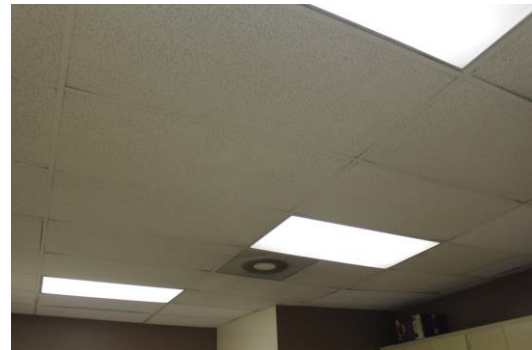
Deficiency Description: 2'W x 4'L three 32 watt T8 grid ceiling mount interior light fixture are at end of useful life.

Description of Work: Replace the existing interior light fixture with a new interior light fixture.

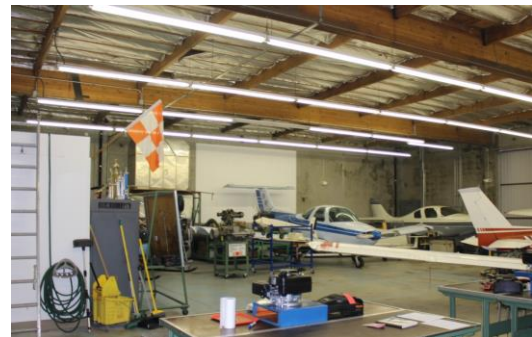
Deficiency Description: 8-foot Interior fluorescent fixture have inefficient T12 lamps and magnetic ballasts.

Description of Work: Replace the fluorescent fixtures with LED type.

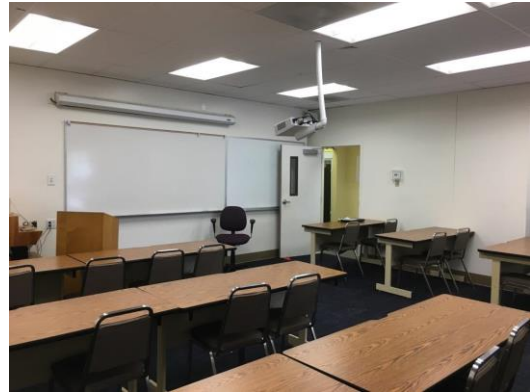
Building Name; Room or Area: Administration/Hangar Building
Equipment Tag: Fire Alarm
Year Installed: NA
Expected Useful Life (Yrs):
Remaining Useful Life (Yrs)
Priority: 3: RECOMMENDED (Address in Years 5 to 10)
Quantity/Unit of Measure: 10,880/SF
Estimate: \$240,400
Deficiency Description: *The building is not equipped with a fire alarm system or the existing fire alarm system is at the end of its industry rated useful life.*
Description of Work: *Provide a fully addressable fire alarm control panel with associated initiating and signaling devices.*

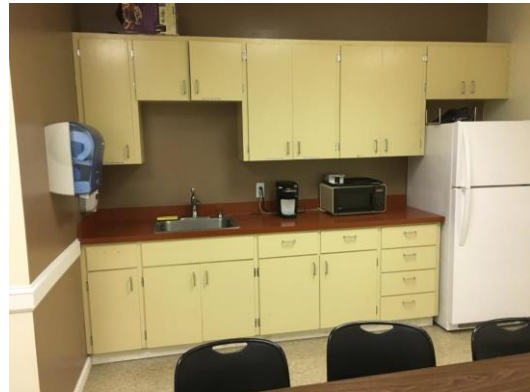
Building Name; Room or Area: Administration/Hangar Building; Break Room
Equipment Tag: NA
Year Installed: 1977
Expected Useful Life (Yrs): 30
Remaining Useful Life (Yrs) 1
Priority: 1: IMMEDIATE (Address in Year 0-2)
Quantity/Unit of Measure: 10/LF
Estimate: \$10,000
Deficiency Description: *Original casework and shelving are worn and damaged.*
Description of Work: *Refinish or replace original cabinets and countertops*

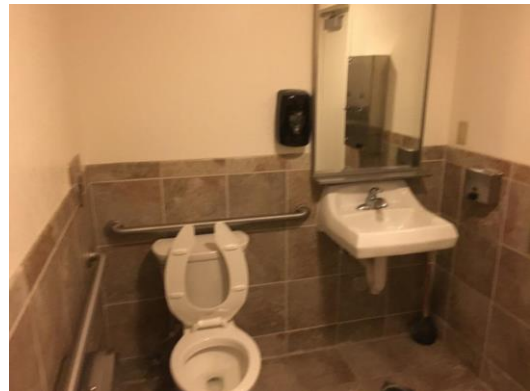
Building Name; Room or Area: Administration/Hangar Building; New Toilet Room at Hangar
Equipment Tag: NA
Year Installed: NA
Expected Useful Life (Yrs):
Remaining Useful Life (Yrs)
Priority: 1: IMMEDIATE (Address in Year 0-2)
Quantity/Unit of Measure: 60/SF
Estimate: \$64,400
Deficiency Description: *Inadequate or non-existent ADA restrooms.*
Description of Work: *Provide a new disabled accessible single occupant restroom.*

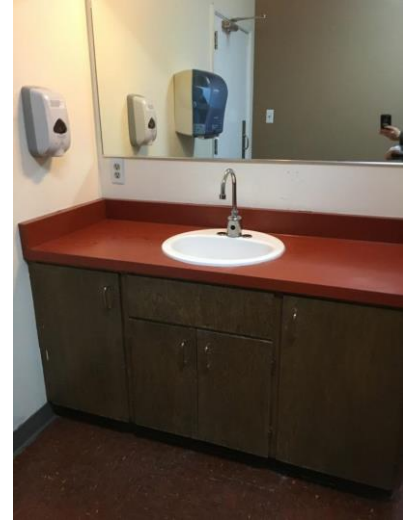
Building Name; Room or Area: Administration/Hangar Building; Men's Restroom
Equipment Tag: NA
Year Installed: NA
Expected Useful Life (Yrs): NA
Remaining Useful Life (Yrs)
Priority: 1: IMMEDIATE (Address in Year 0-2)
Quantity/Unit of Measure: 100/SF
Estimate: \$107,400
Deficiency Description: *Inadequate or non-existent ADA restrooms.*
Description of Work: *Provide a new disabled accessible single occupant restroom.*

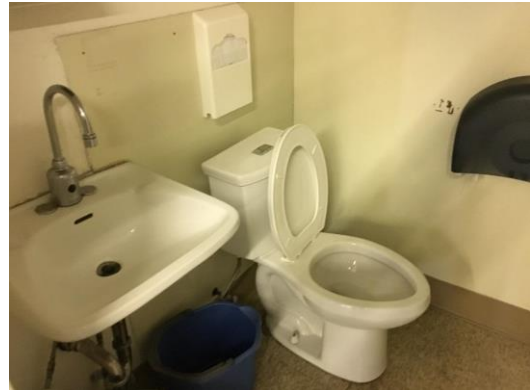
Deficiency Description: *Inadequate or non-existent ADA restrooms.*

Description of Work: *Provide a new disabled accessible single occupant restroom.*

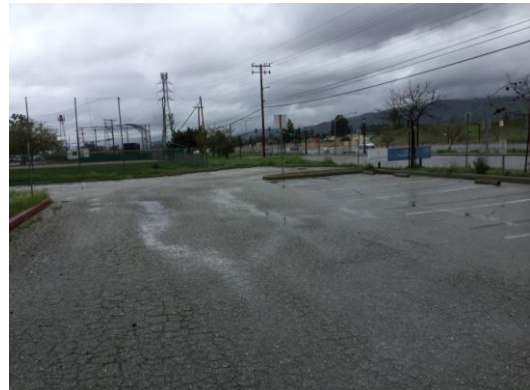
Deficiency Description: *AC paving has major damage and/or structure failure.*

Description of Work: *Repair and replace AC pavement section.*

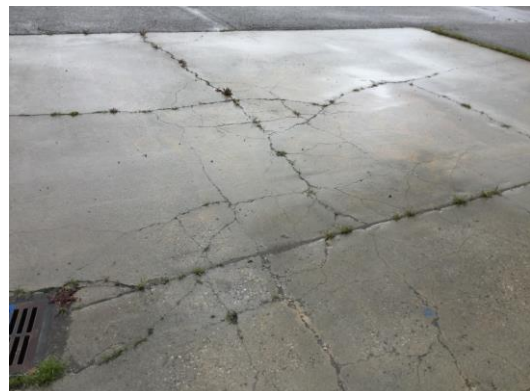
Deficiency Description: *AC paving has faded or has minor weathering.*

Description of Work: *Provide chip seal.*

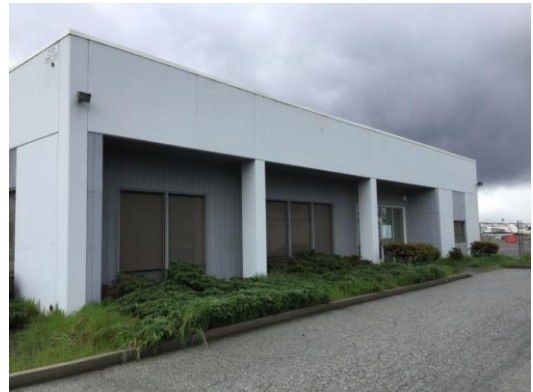
Quantity/Unit of Measure: 2/
Estimate: \$4,400
Deficiency Description: Site lighting (halogen) is beyond its useful life.

Description of Work: Replace site lighting with LED type.

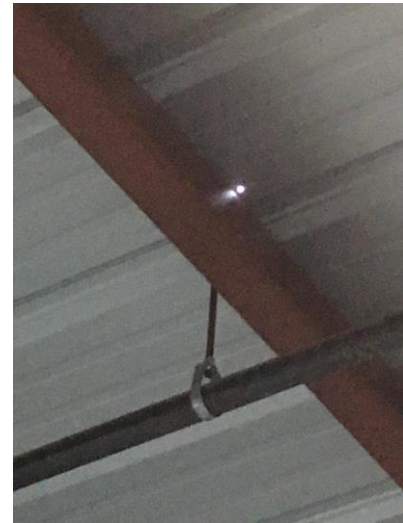
Deficiency Description: Metal roof has a hole that daylights, letting rainwater into the hangar unit.

Description of Work: Seal the hole in the metal roof.

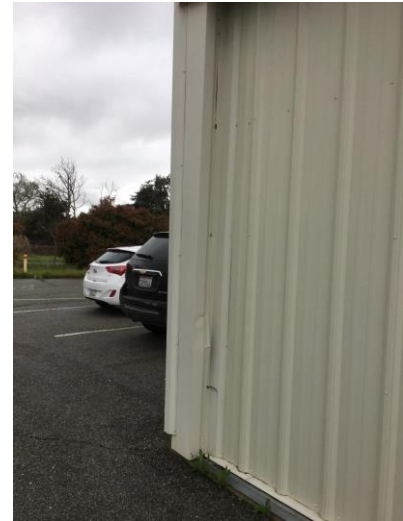
Building Name; Room or Area: Hangar Building; I-34

Deficiency Description: Exterior metal sheathing has impact damage.

Description of Work: Repair damaged metal panels.

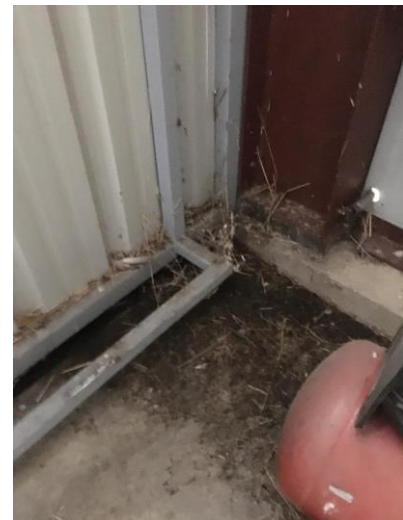
Building Name; Room or Area: Hangar Building; I-8

Deficiency Description: Water intrusion is observed at the bottom corner of the unit creating dirt and possibly mold.

Description of Work: Seal gaps between metal panels.

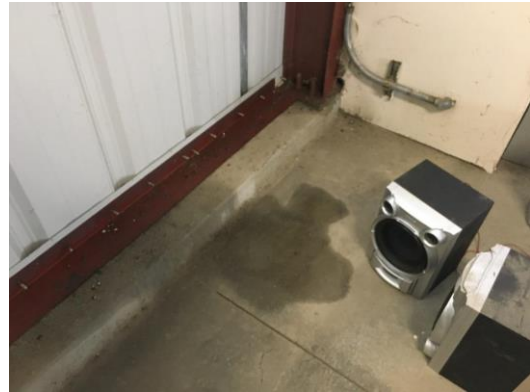
Building Name; Room or Area: Hangar Building; I-34
Equipment Tag: NA
Year Installed: 2005
Expected Useful Life (Yrs):
Remaining Useful Life (Yrs)
Priority: 4: Miscellaneous (Further Investigation Required)
Quantity/Unit of Measure: 6/LS
Estimate:
Deficiency Description: *Water intrusion is observed near door and window.*
Description of Work: *Further investigation required.*

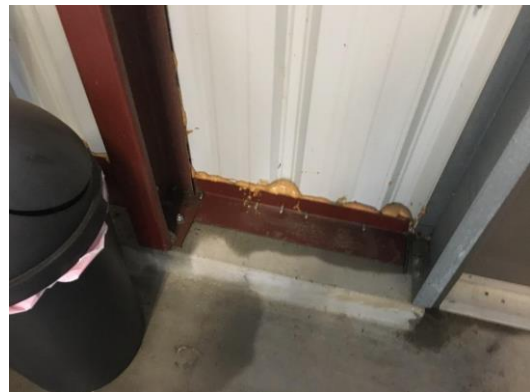
Building Name; Room or Area: Hangar Building; I-31
Equipment Tag: NA
Year Installed: 2005
Expected Useful Life (Yrs):
Remaining Useful Life (Yrs)
Priority: 4: Miscellaneous (Further Investigation Required)
Quantity/Unit of Measure: 6/LS
Estimate:
Deficiency Description: *Water intrusion is observed near door and wall.*
Description of Work: *Further investigation required.*

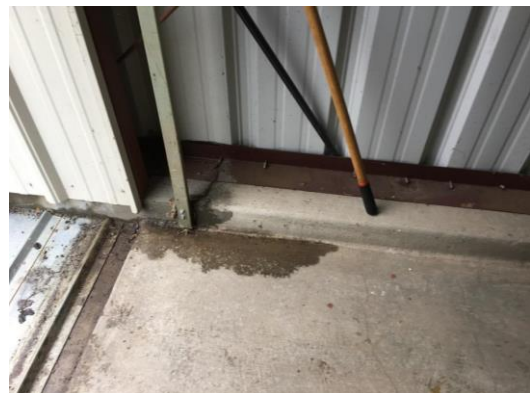
Building Name; Room or Area: Hangar Building; H-28
Equipment Tag: NA
Year Installed: 2005
Expected Useful Life (Yrs):
Remaining Useful Life (Yrs)
Priority: 1: IMMEDIATE (Address in Year 0-2)
Quantity/Unit of Measure: 3/LF
Estimate: \$300
Deficiency Description: *Water intrusion into the into through gate and wall.*
Description of Work: *Seal gaps and cracks between metal joints.*

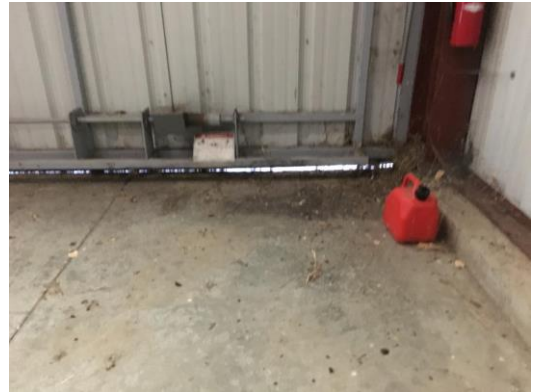
Building Name; Room or Area: Hangar Building; G-18
Equipment Tag: NA
Year Installed: 2005
Expected Useful Life (Yrs):
Remaining Useful Life (Yrs)
Priority: 2: CRITICAL (Address in Years 2 to 5)
Quantity/Unit of Measure: 320/LF
Estimate: \$3,200
Deficiency Description: Excessive gap between bottom of gate track and the concrete floor.
Description of Work: Provide rubber gasket/door seep to cover the gaps

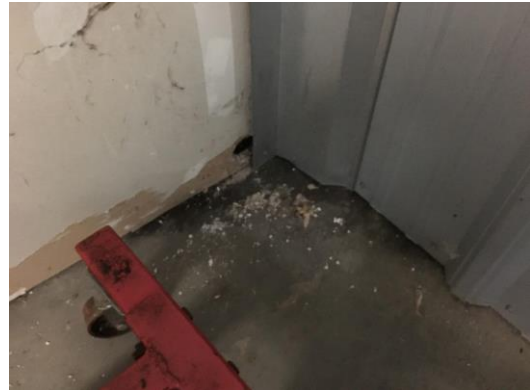
Building Name; Room or Area: Hangar Building; H-28
Equipment Tag: NA
Year Installed: 2005
Expected Useful Life (Yrs):
Remaining Useful Life (Yrs)
Priority: 2: CRITICAL (Address in Years 2 to 5)
Quantity/Unit of Measure: 4/EA
Estimate: \$2,000
Deficiency Description: *Hole is left uncovered possibly from initial construction. Potential for pest entrance into the unit.*
Description of Work: *Cover the hole in the wall.*

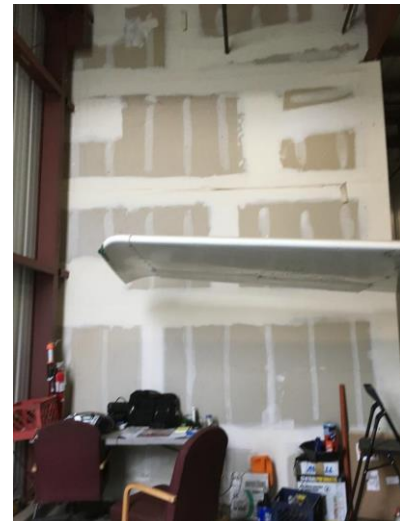
Building Name; Room or Area: Hangar Building; H-28
Equipment Tag: NA
Year Installed: 2005
Expected Useful Life (Yrs):
Remaining Useful Life (Yrs)
Priority: 3: RECOMMENDED (Address in Years 5 to 10)
Quantity/Unit of Measure: 150/SF
Estimate: \$1,200
Deficiency Description: *Unfinished gypsum board walls.*
Description of Work: *Finish the gypsum board with paint*

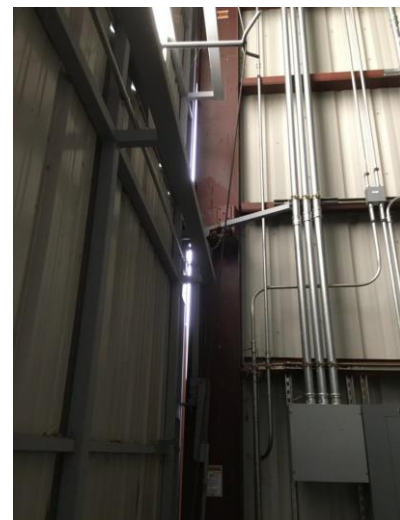
Building Name; Room or Area: Hangar Building; I-8
Equipment Tag: NA
Year Installed: 2005
Expected Useful Life (Yrs):
Remaining Useful Life (Yrs)
Priority: 1: IMMEDIATE (Address in Year 0-2)
Quantity/Unit of Measure: 1/EA
Estimate: \$500
Deficiency Description: *Gate does not fully close, leaving excessive vertical gap on the sides, potentially letting rainwater into the unit.*
Description of Work: *Fix and service the overhead gate to close completely without leaving a gap.*

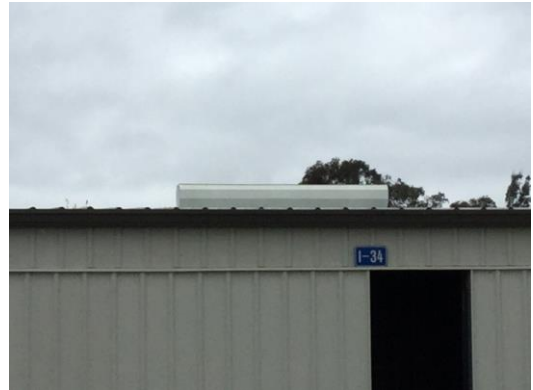
No Visual Inspection Report was conducted previously, however for heating, ventilating, and air conditioning there were gravity vented roof caps that were not properly bird screened and could allow birds into hangers. Recommended work is included in the deficiency report. No other HVAC related systems were assessed.

Building Name; Room or Area: Hangar Building
Equipment Tag: Gravity Ventilator Opening
Year Installed: 2005
Expected Useful Life (Yrs):
Remaining Useful Life (Yrs)
Priority: 1: IMMEDIATE (Address in Year 0-2)
Quantity/Unit of Measure: 1,000/SF
Estimate: \$43,000
Deficiency Description: Roof ventilation hood requires bird screen over openings.
Description of Work: Provide bird screen around roof ventilation hood and install.

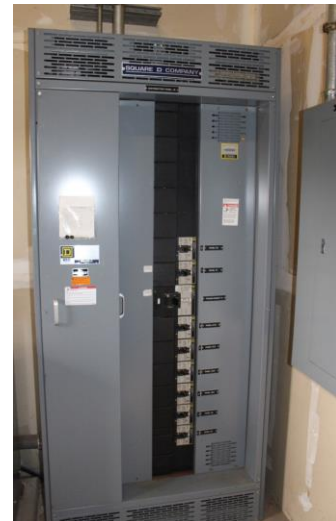
Building Name; Room or Area: Hangar Building
Equipment Tag: Main Swbd
Year Installed: 2005
Expected Useful Life (Yrs): 20
Remaining Useful Life (Yrs) 7
Priority: 3: RECOMMENDED (Address in Years 5 to 10)
Quantity/Unit of Measure: 1/EA
Estimate: \$16,600
Deficiency Description: The 400A metered main switchboard (3P, 277/480) is at or approaching the end of its useful life.
Description of Work: Replace the existing metered main switchboard with a new metered main switchboard.

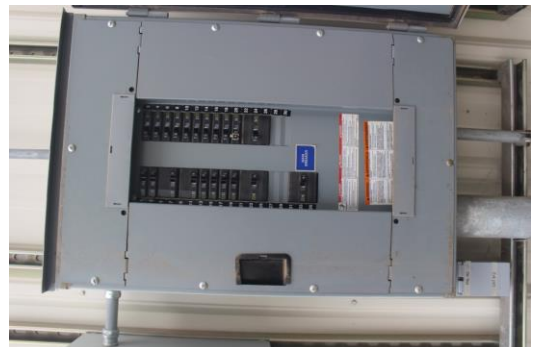
Building Name; Room or Area: Hangar Building
Equipment Tag: Panelboards
Year Installed: 2005
Expected Useful Life (Yrs): 30
Remaining Useful Life (Yrs) 17
Priority: 3: RECOMMENDED (Address in Years 5 to 10)
Quantity/Unit of Measure: 20/EA
Estimate: \$29,700
Deficiency Description: The panelboard or switchboard has not been thermally imaged.
Description of Work: Test panelboard or switchboard with a thermal imaging device as part of a maintenance plan.

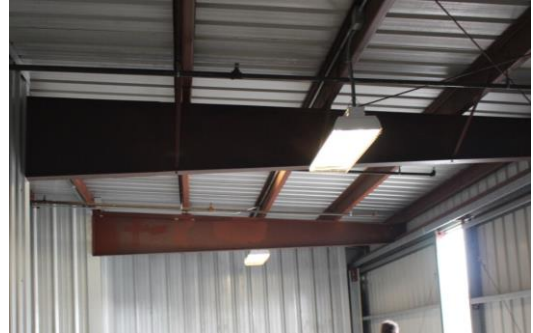
Building Name; Room or Area: Hangar Building
Equipment Tag: Int, Ltg
Year Installed: 2005
Expected Useful Life (Yrs): 20
Remaining Useful Life (Yrs) 7
Priority: 3: RECOMMENDED (Address in Years 5 to 10)
Quantity/Unit of Measure: 325/EA
Estimate: \$227,400
Deficiency Description: 2'W x 4'L (2) 32 watt T8 chain hung ceiling mount interior light fixture is approaching the end of its useful life.
Description of Work: Replace the existing interior light fixture with a new interior light fixture.

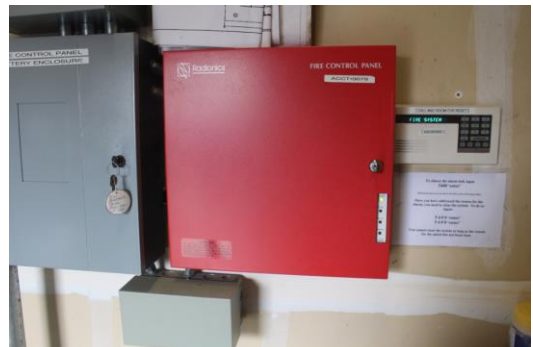
The hangar buildings have a fire alarm system to monitor the installed sprinkler systems. There were no alarms or trouble conditions indicated on the main fire alarm control panel (FACP). The FACP is nearing the end its industry-standard rated life. Fire alarm panels have shorter lifetimes than most other electrical equipment due to their electronic-based nature. They become obsolete and harder to maintain over time.

Building Name; Room or Area: Hangar Building
Equipment Tag: Fire Alarm
Year Installed: 2005
Expected Useful Life (Yrs): 15
Remaining Useful Life (Yrs) 2
Priority: 2: CRITICAL (Address in Years 2 to 5)
Quantity/Unit of Measure: 1/EA
Estimate: \$17,100
Deficiency Description: The main fire alarm control panel [addressable without voice] (excluding wire and conduit) is at or approaching the end of its useful life.
Description of Work: Replace the existing main fire alarm control panel with a new main fire alarm control panel.

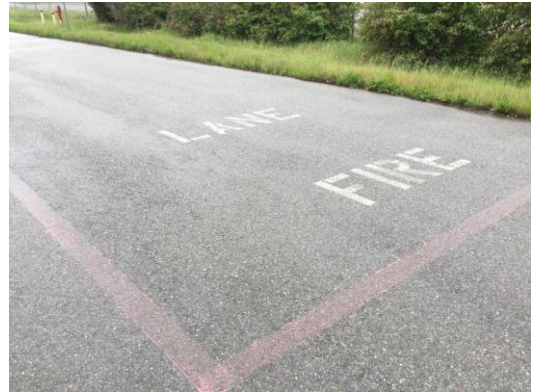
Building Name; Room or Area: Hangar Building
Equipment Tag: Pavement
Year Installed: 2005
Expected Useful Life (Yrs):
Remaining Useful Life (Yrs)
Priority: 3: RECOMMENDED (Address in Years 5 to 10)
Quantity/Unit of Measure: 600/SF
Estimate: \$7,200
Deficiency Description: AC paving has faded or has minor weathering.
Description of Work: Provide chip seal.
